Cornsay Colliery Fish Easement

The first easement to be implemented under the CRF project was delivered on time in September 2012 addressed a road culvert at Cornsay Colliery, located on Hedleyhope Burn a tributary of the River Deerness (Figure 1).

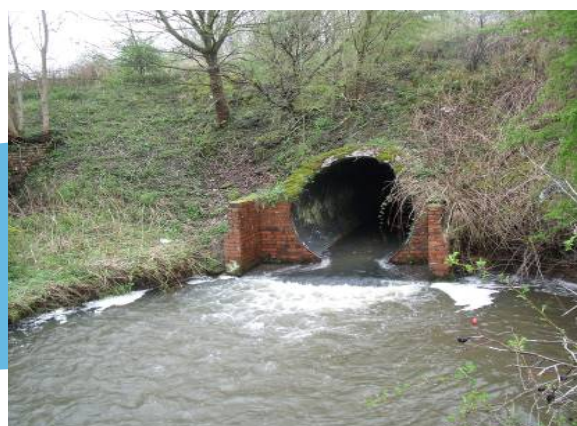
The Hedleyhope Burn measures 9.2km in length and flows down from Tow Law and into the Deerness at Esh Winning. The road culvert at Cornsay Colliery had been cutting off access to over 5km of good quality habitat under most flow conditions as the culvert, a 30m corrugated steel pipe, had rapid and very shallow uniform flows when water levels were low and extremely fast concentrated high velocity flows at high water. The extensive erosion pool immediately downstream of the culvert evidenced the force of the water leaving the culvert (Figure 2).

A wide concrete step, normally rising 150 to 200mm above the surface of the water obstructed fish from gaining access to, and attempting to run, the culvert itself.

Figure 2 - Original erosion pool and concrete step

The solution agreed was to replace the original scour pool with a series of rock pools which would provide a variety of flows for different fish species, and drown out the concrete step by increasing the water level to create a slower deeper flow through the culvert (Figure 3). Backing up water does not increase flood risk under any flow conditions, as the site lies within a deep depression with no vulnerable residential or industrial buildings upstream or downstream.

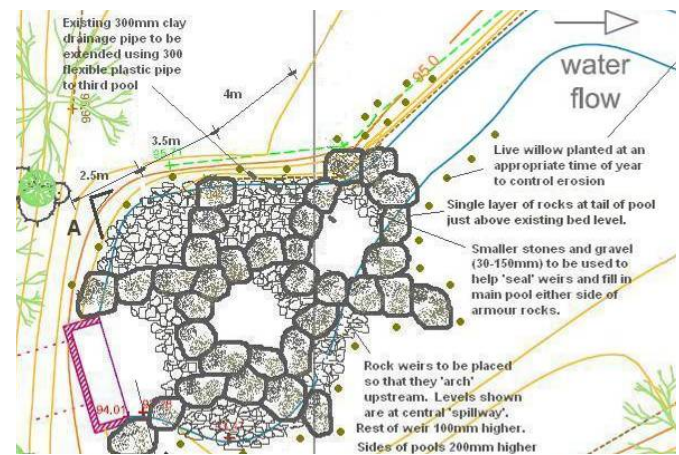
Figure 3 - Easement design drawing

Levels for each of the spillways were taken. The new surface level of the first pool needed to be 300mm higher than the original concrete platform, so a working level taken from bolts within the culvert was taken and used to place the initial spillway rock. The rest of the upper rock barrage was built around the spillway, "arched" upstream and keyed into rock protecting the banksides and narrowing the erosion pool, concentrating flows to the centre of the structure, especially important at lower flows and maximising stability at high volumes. Levels for the two subsequent weirs were confirmed against the first, upstream structure. Recognising the velocity of flows, generated in a high rainfall upland area with ground often at capacity and concentrated by the culvert, 2-3 tonne rocks were largely buried in the stream bed, with similar sized rocks keyed into the base, into each other and into the rocks forming a continuous line of bank protection (Figure 3 above and 4 below).

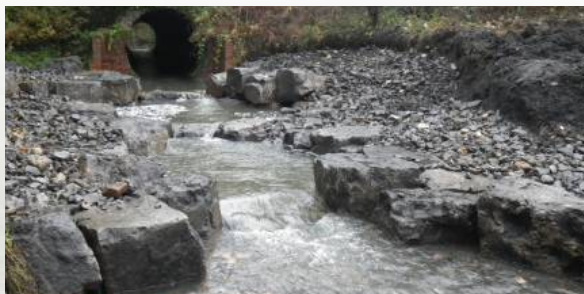
Figure 4 - Completed rock ramp easement

As ever with the construction of these structures there are concerns about the retention of water at low flows. Quick setting concrete in sandbags was used to plug of the larger holes created by the use of such large rocks. It is hoped that the sandbags will accelerate the accumulation of gravels and silts through the structure as it settles down, improving water retention. In addition larger gravels, puddled with clay were used to infill behind bankside revetments behind the first pool, filling in the edges of the original erosion pool.

Surplus rock armour was used along the northern bank to reduce erosion and willow spiling will be installed at a later stage to further protect the banks from high flows.
