Long Preston Restoration Summary

Final Report

October 2011

Environment Agency

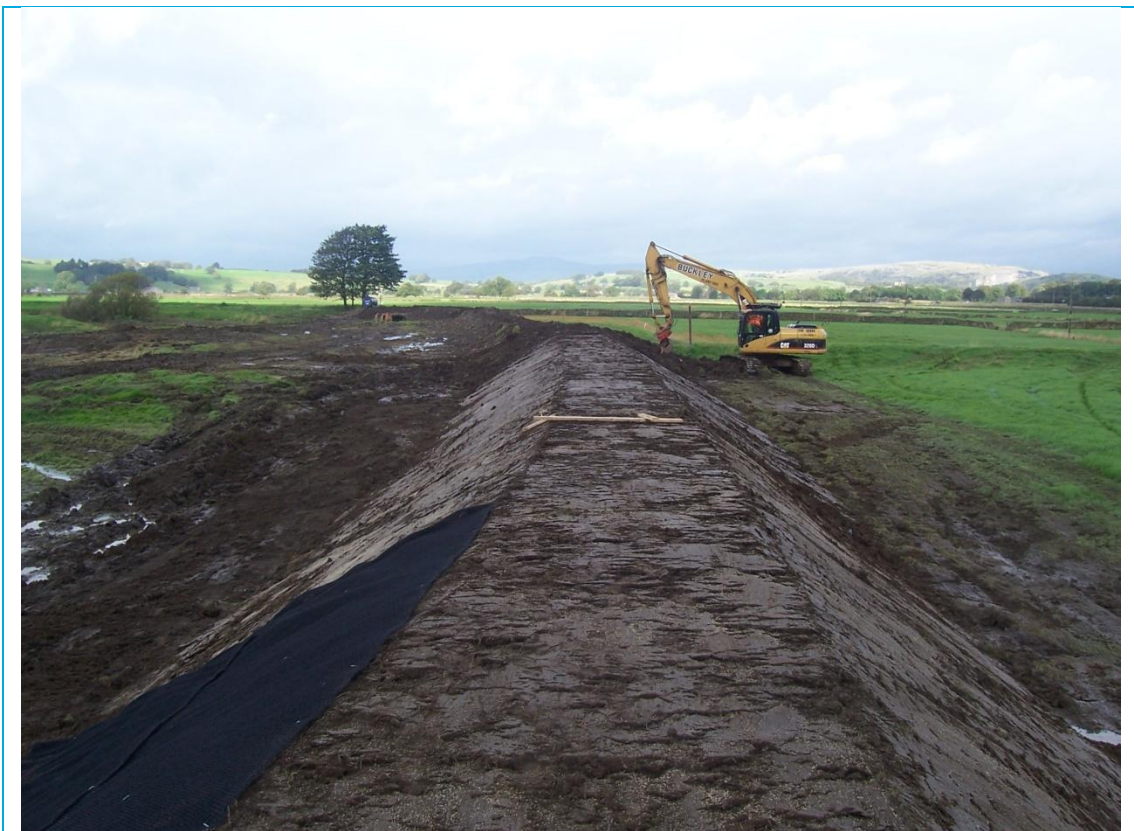
a) Set back flood embankment during construction, looking upstream. Note the flood embankment has been set at a slightly higher level to the original embankment to allow for settlement.

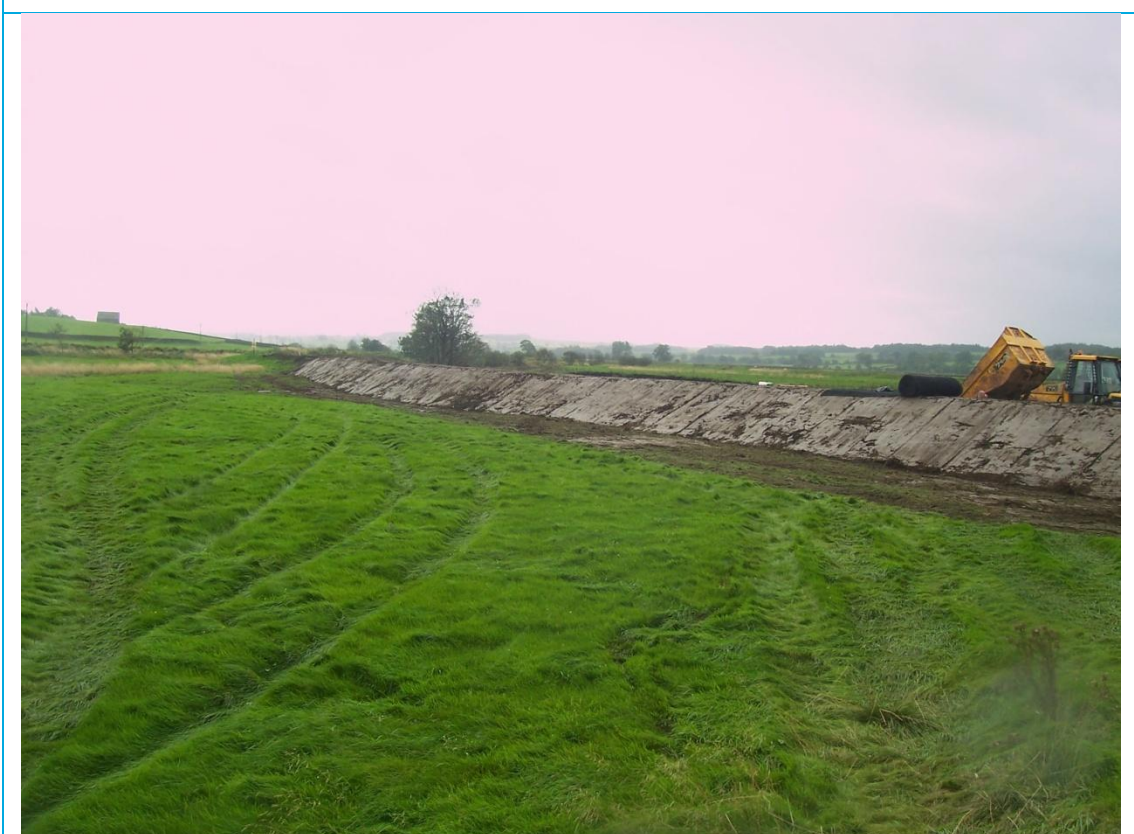
b) View of flood embankment from floodplain side. Seeding was undertaken during the

construction phase and before the embankment was 'smoothed' to minimise seed being moved by the wind.

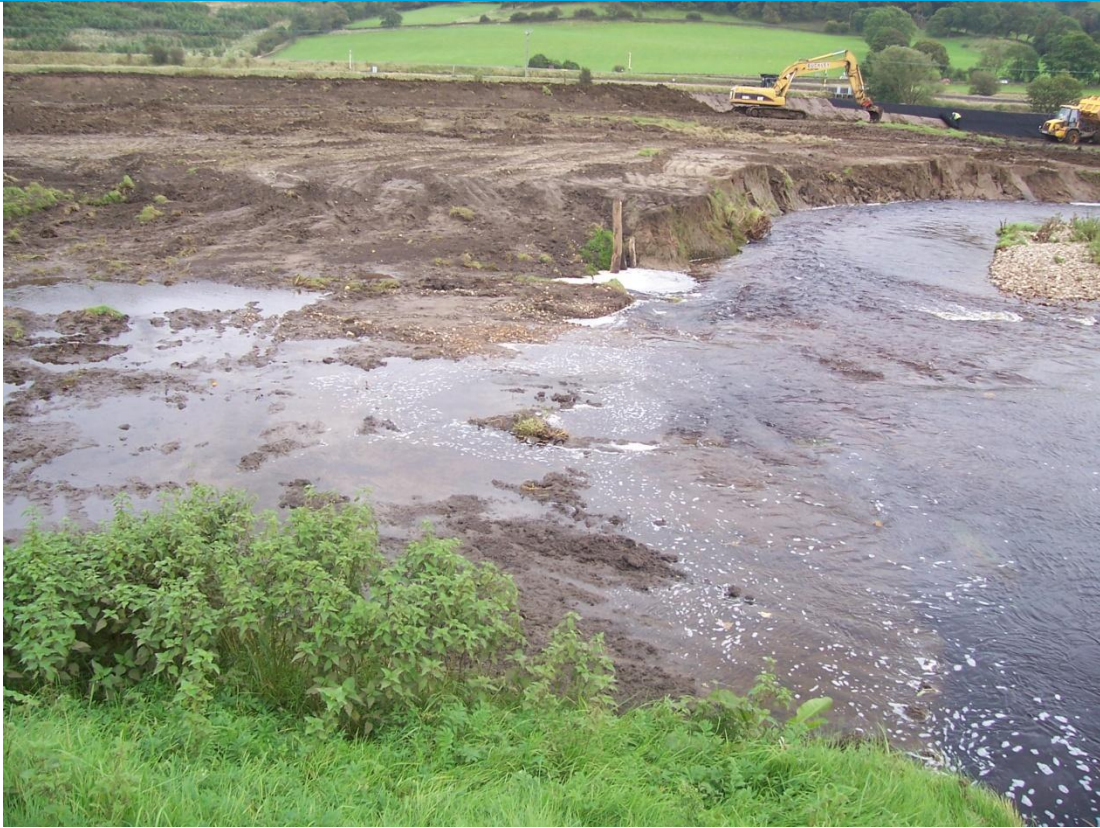
c) View of left hand floodplain where embankment has now been set back. The area where the embankment has been removed from has also been seeded.

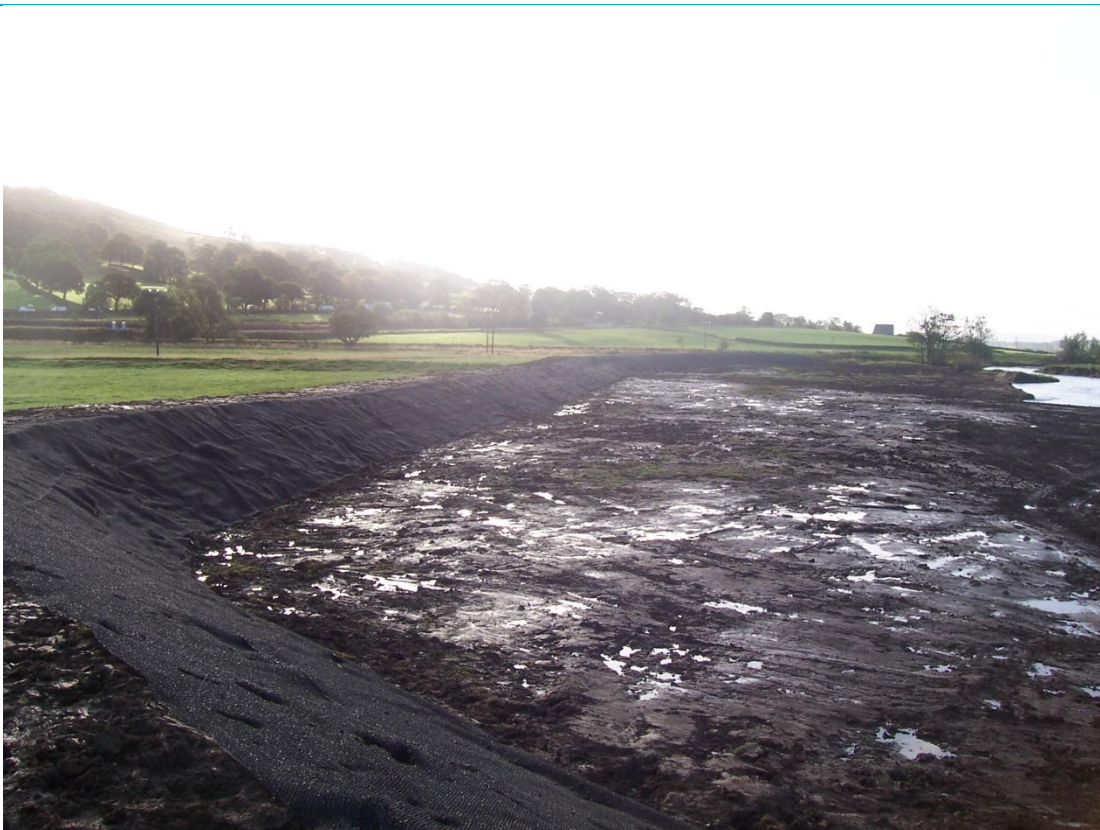
d) Restored floodplain area. Time was spent smoothing this floodplain area post completion

of the flood embankment.

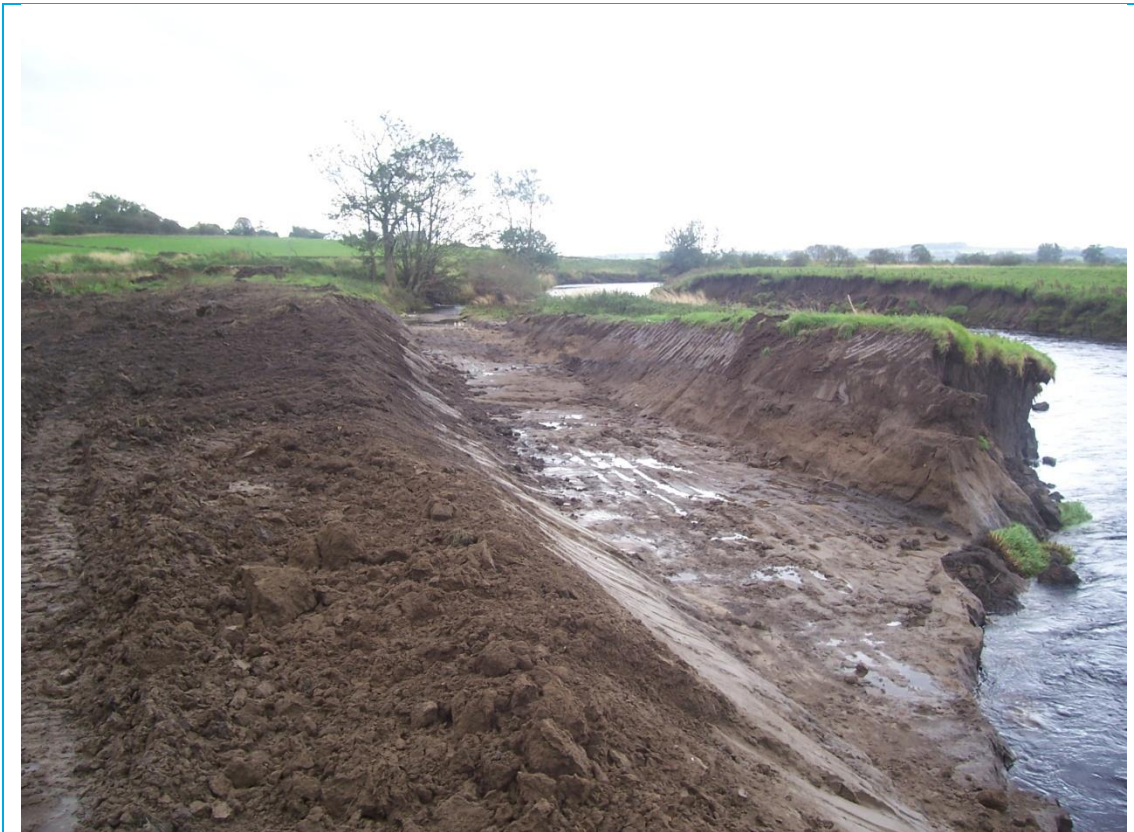
a) View of chute channel looking downstream. Note the water level marks on the right bank of the chute channel showing level of recent flood.

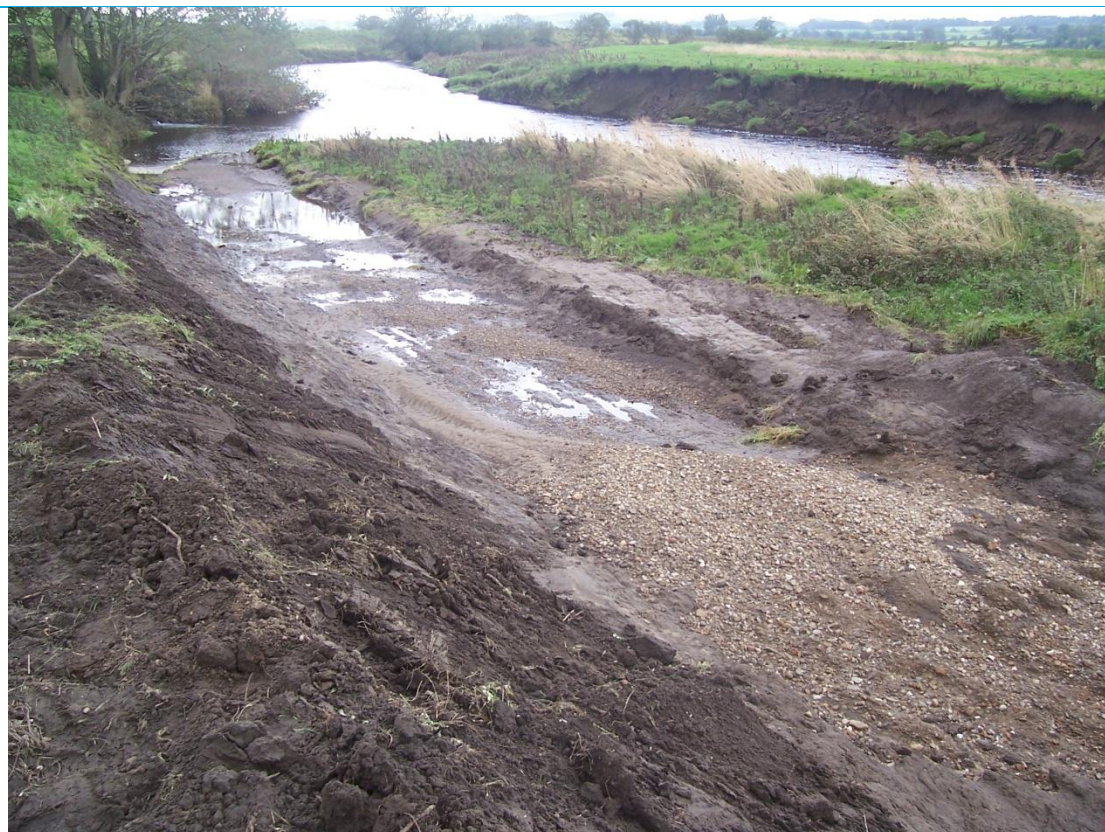
b) Downstream end of chute channel showing gravels exposed during excavation.

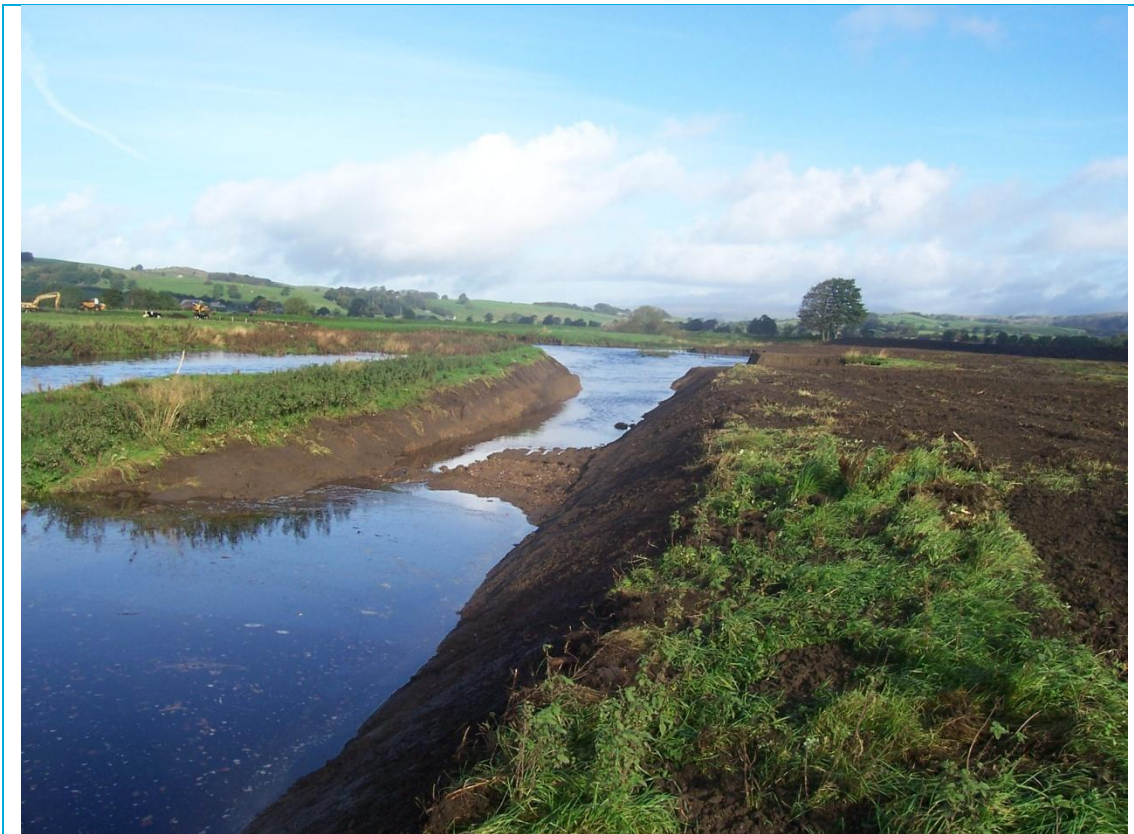
c) Chute channel activated at higher flow, looking upstream. Some sediment deposition was evident after this event.

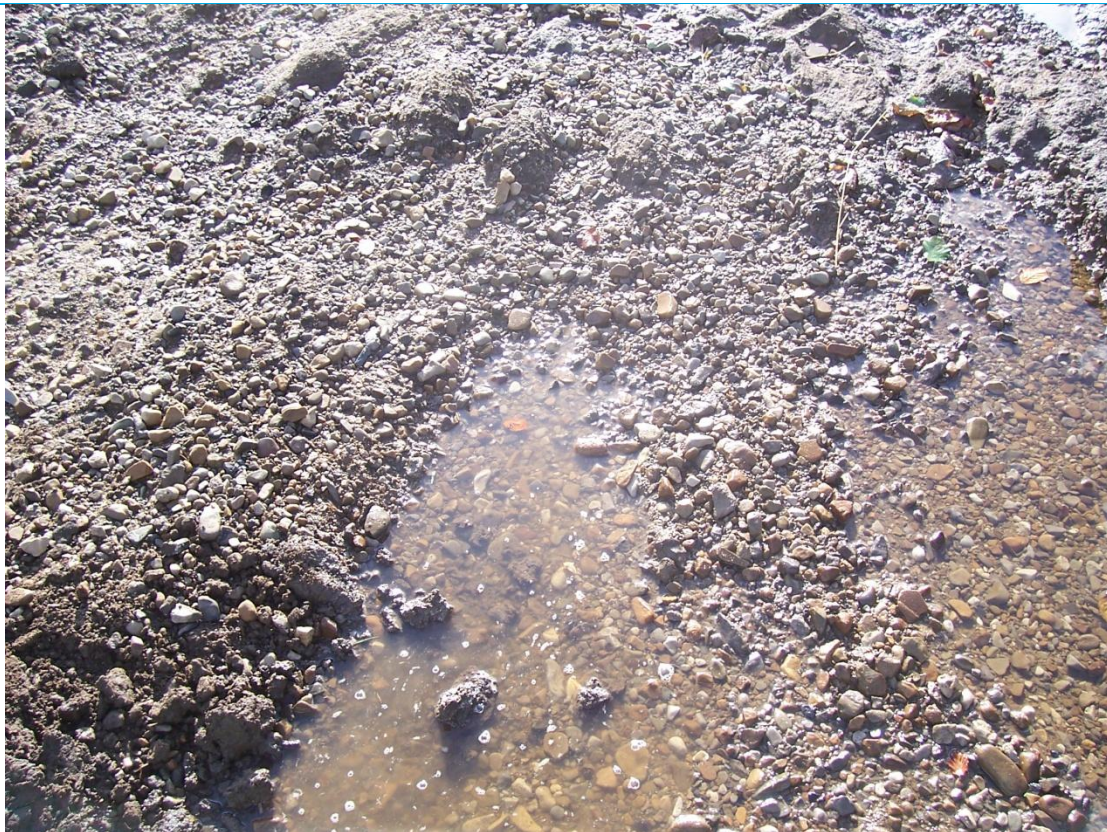
d) Bed composition of exposed gravel section at downstream end of chute channel.

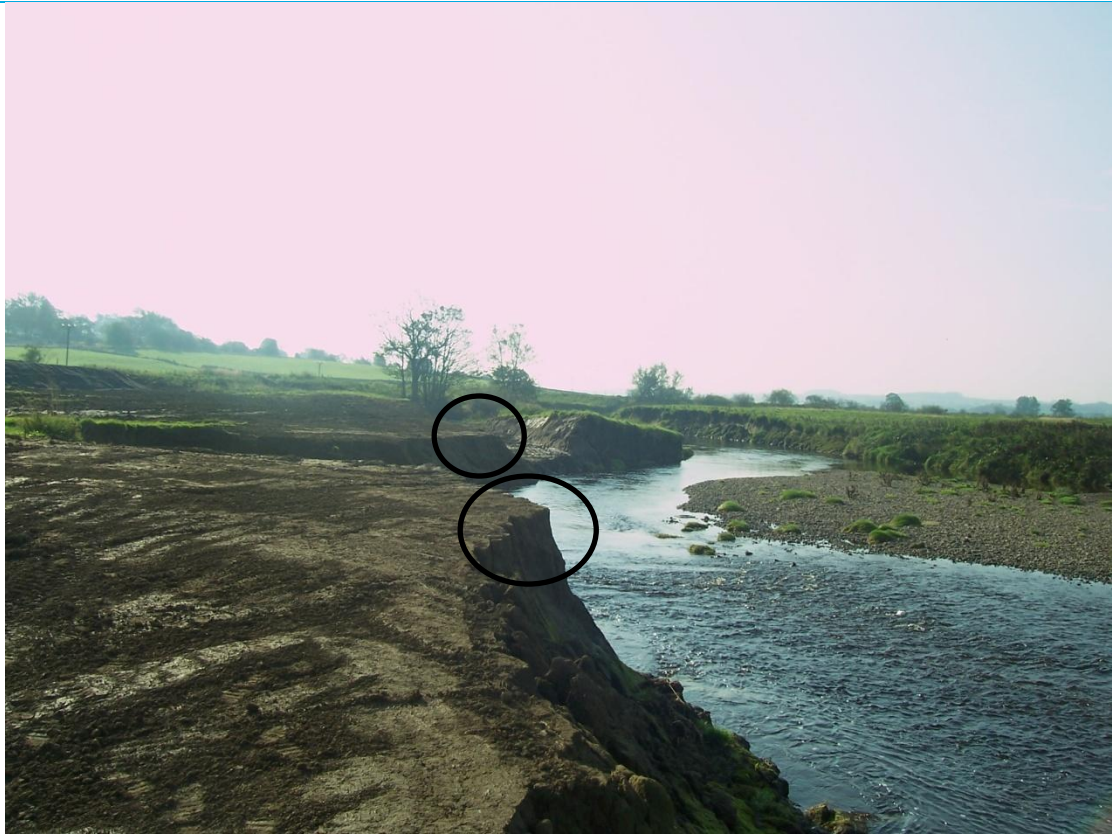
e) Photograph showing some areas of bank likely to be eroded through natural processes.

It is likely there will be some natural modification to the bank immediately upstream of the chute channel (there is a section of bank shown in Figure 2-3, photograph e) **Error! Reference source not found.** which is likely to be eroded at higher flows). The island that has been created by the engineering of the chute channel is also likely to be modified during higher flow events, particularly the upstream end which will be susceptible to erosion. Again, erosion is a natural process so this should not be considered as a negative reaction by the river and will promote seral vegetation community development.

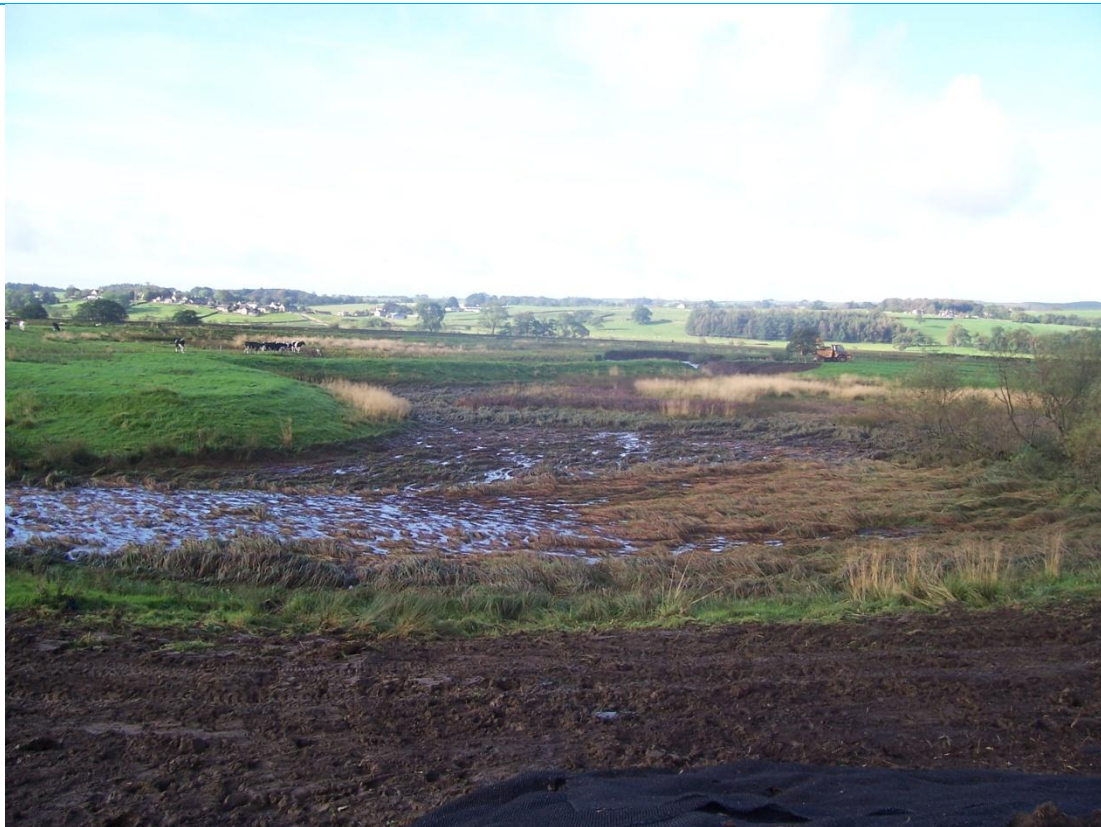
a) Paleo feature that has now been reconnected. This view is looking upstream towards the inlet.

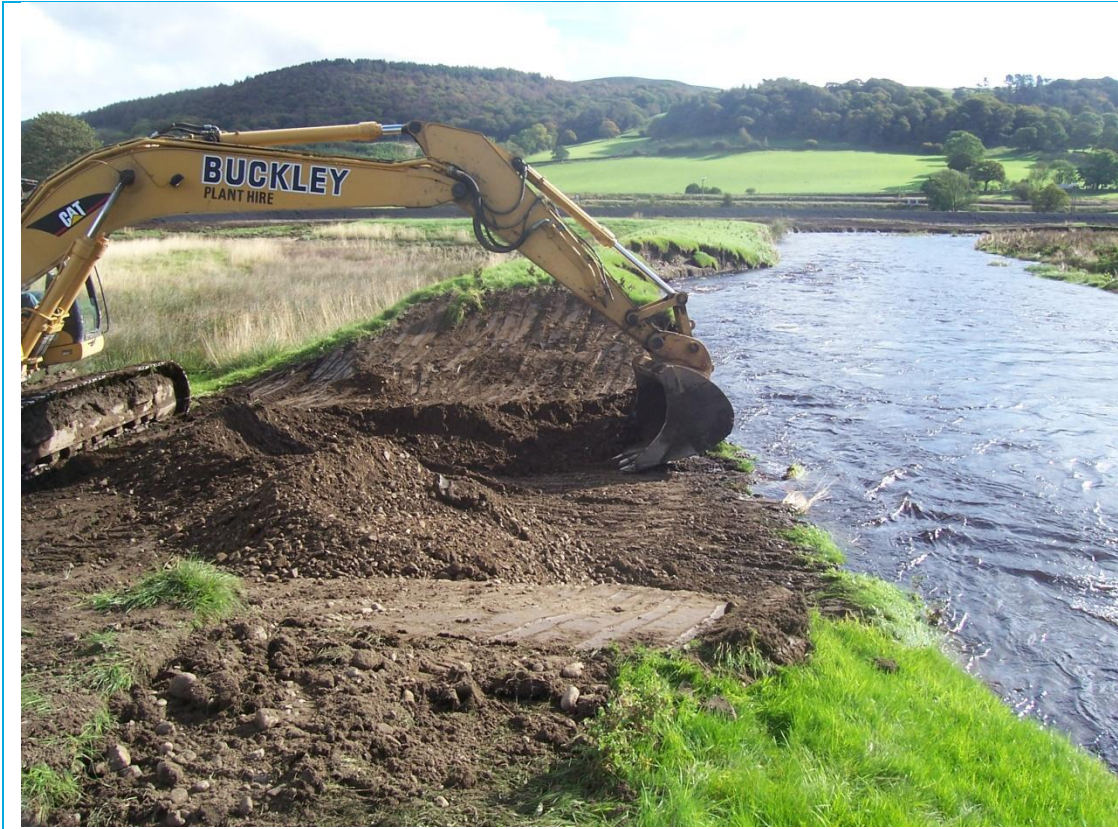
b) Inlet to paleo feature during construction showing exposed gravels at the bed level.

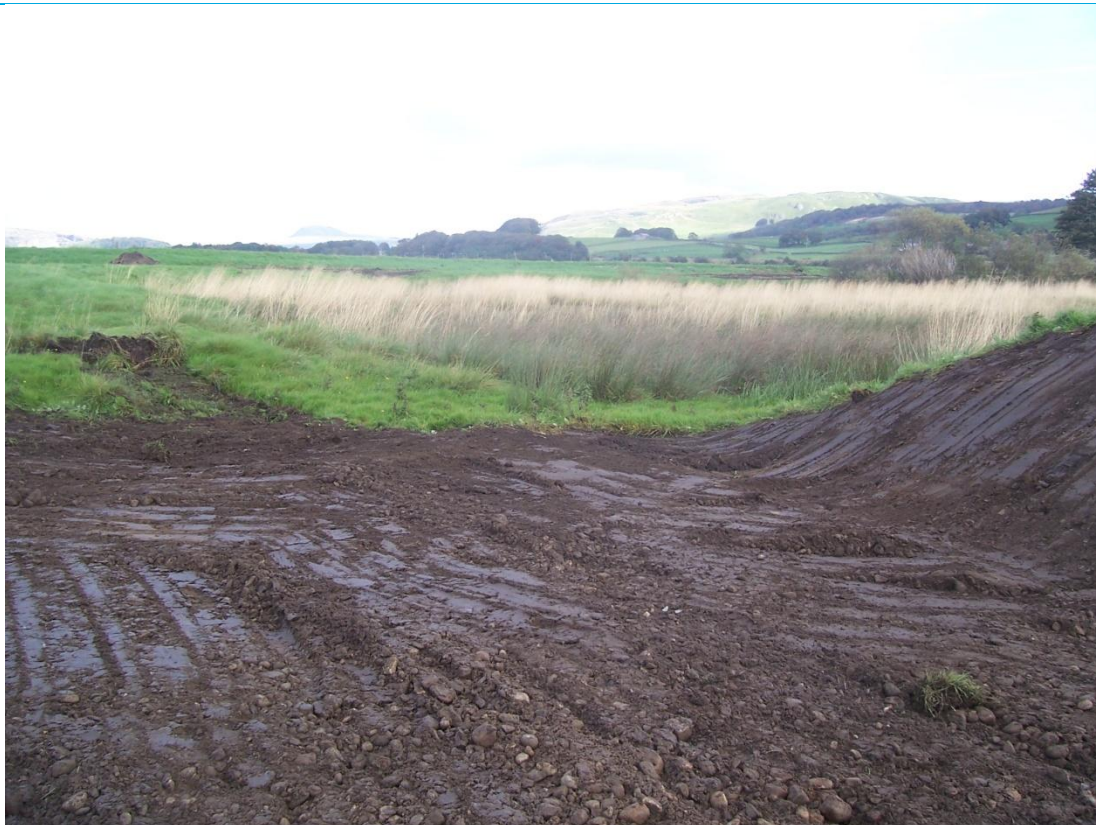
c) View from inlet into the paleo feature showing that the level of the inlet is set at approximately the same bed level as the paleo feature.

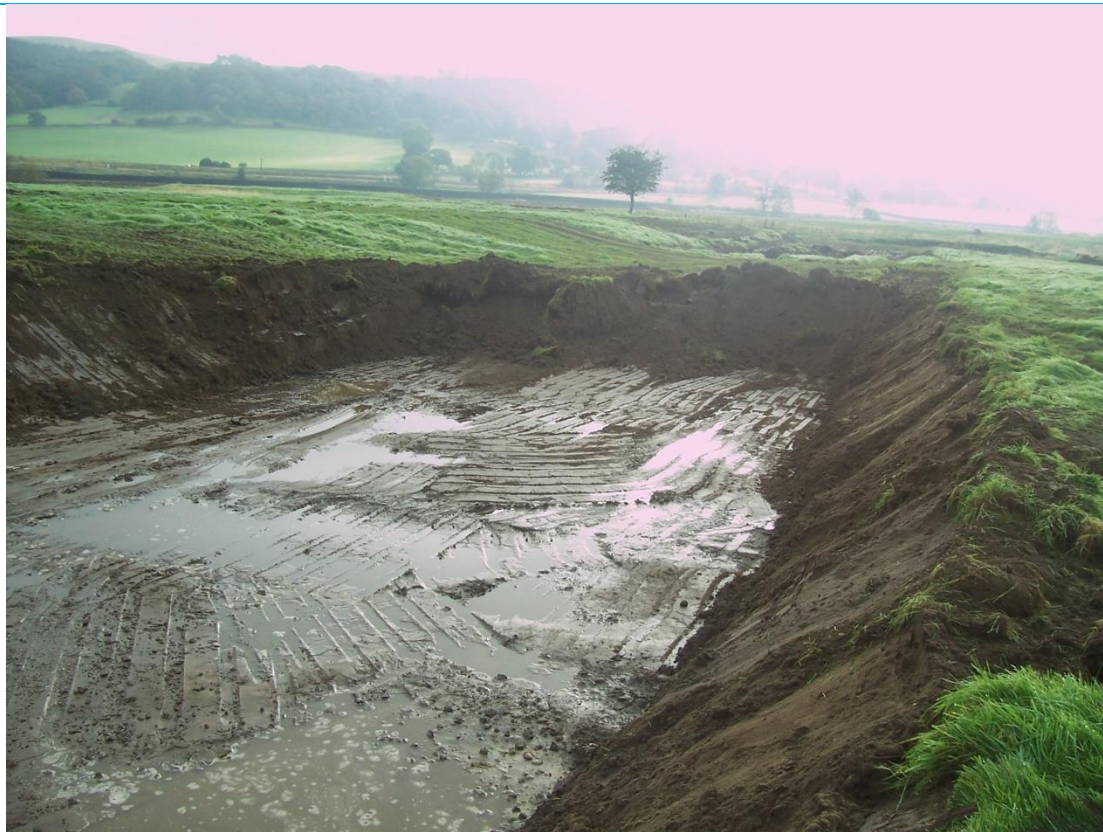
a) Upstream chute channel during construction looking downstream showing fine sediment on bed.

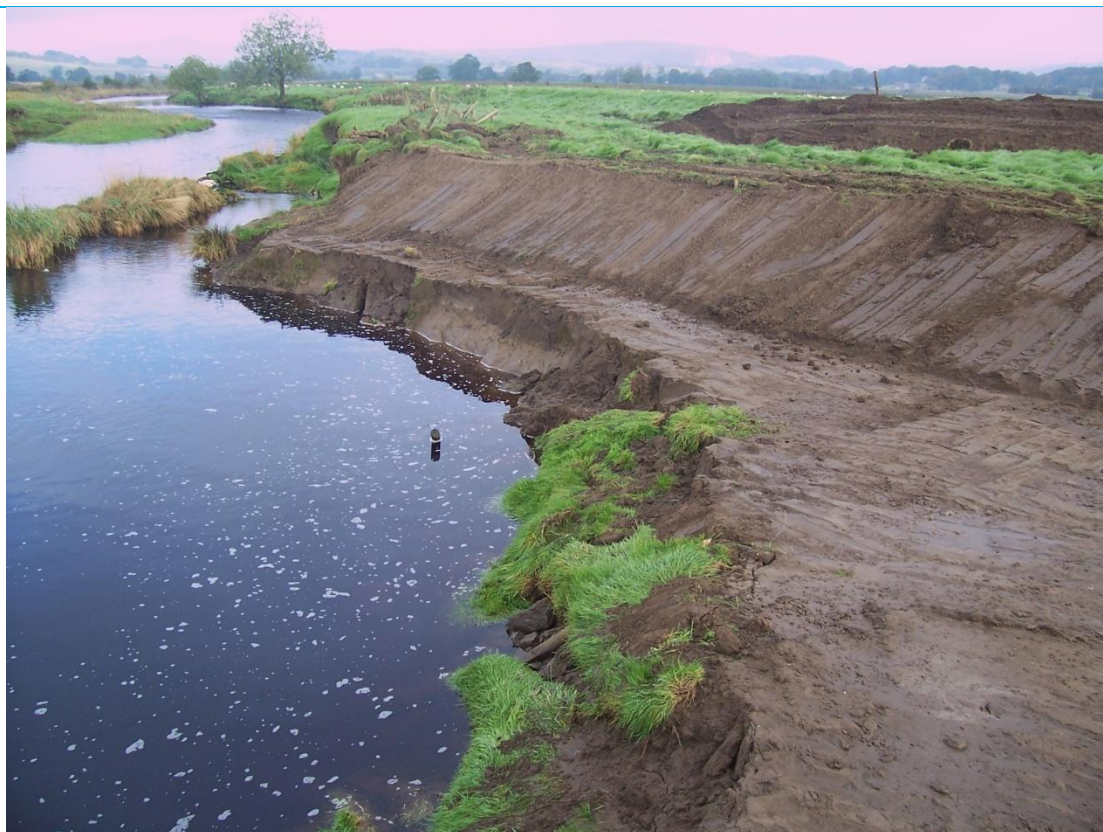
b) Upstream inlet to chute channel (note - entrance angle has now been smoothed off

following this photograph).

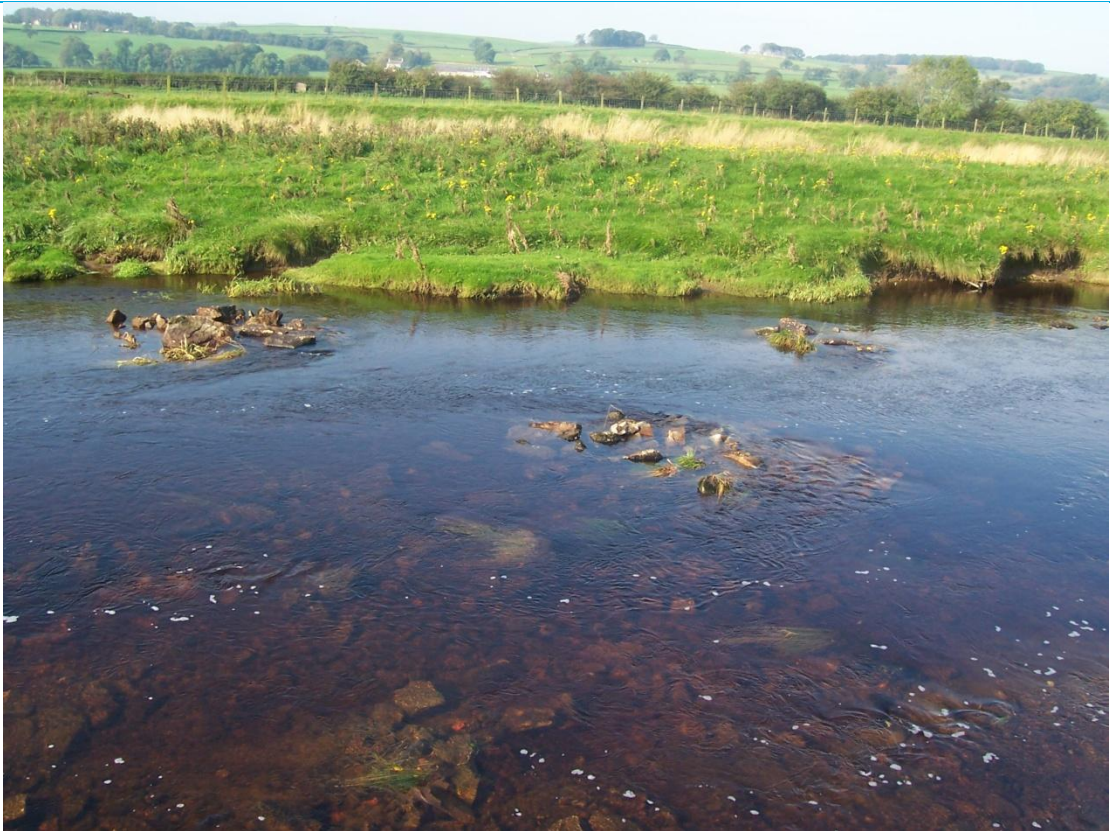
a) Some of installed boulder clusters and general coarsening of the bed towards the left bank

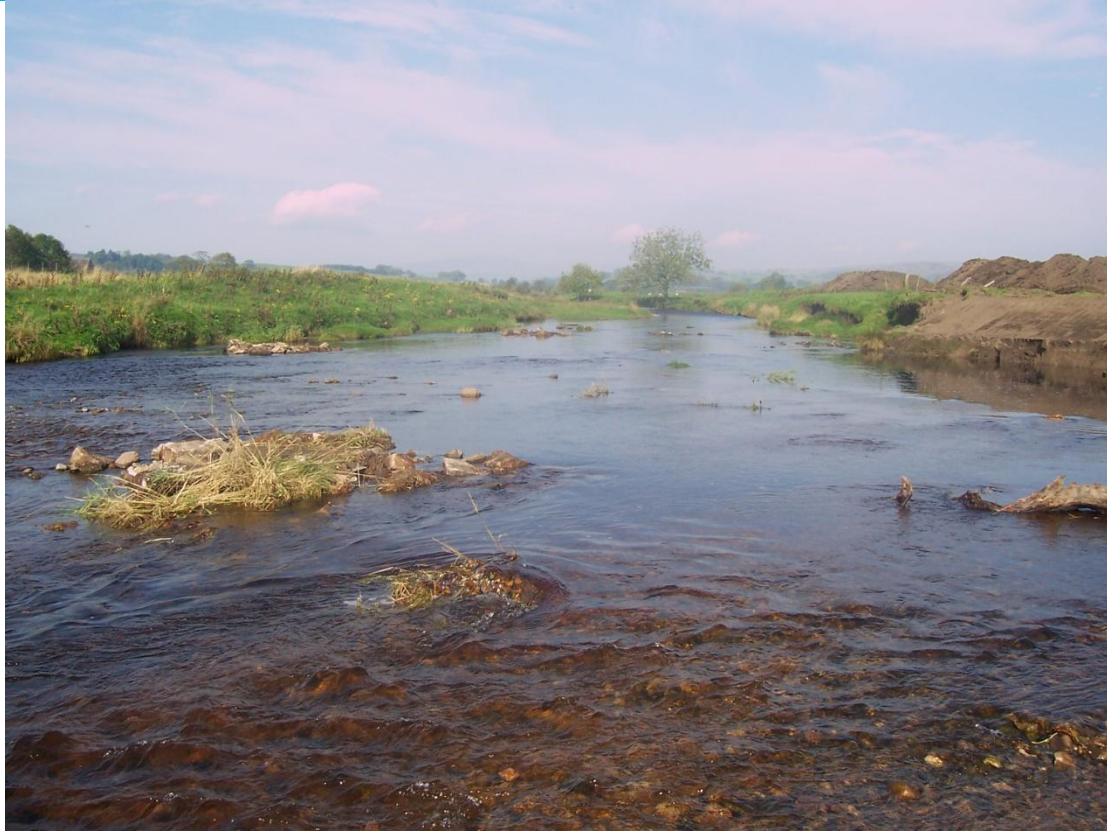
b) Boulder cluster network and bed coarsening looking downstream (note flow variation improving the diversity across the uniform glide).

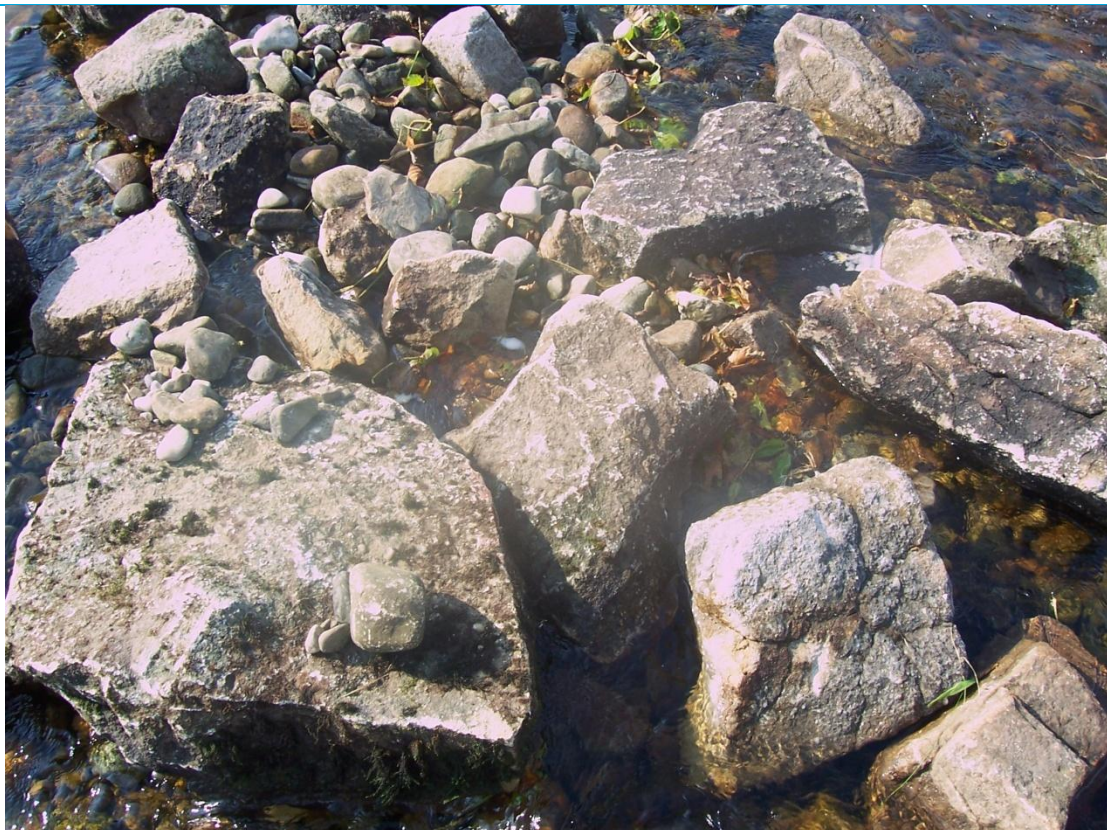
c) Boulder cluster composition showing diversity in material size and distribution.
