River Welland: Drayton

Version 1 (25.02.12)

Location:	Downstream of Ashley Gauging Weir
Upstream Grid Ref:	SP819916
Length:	c 1700m
Completion Date:	Early winter 2011
Cost:	£55,000
Partners:	The scheme was implemented by the Environment Agency with the co-operation and agreement of the adjacent landowners (Matthew and Melanie Robinson and Alister Brooke-Clarke) and in-kind support from the Welland Rivers Trust and the Wild Trout Trust.

Summary of Techniques: Faggot, woody debris and coir roll flow deflectors; channel pinching using faggots, woody debris and coir rolls; introduction of gravels to augment and create riffles; bank toe protection using rock and coir; new cattle drinkers; riverside fencing; selected tree works including crown-lifting and pollarding; new tree and shrub planting; artificial otter holt construction.

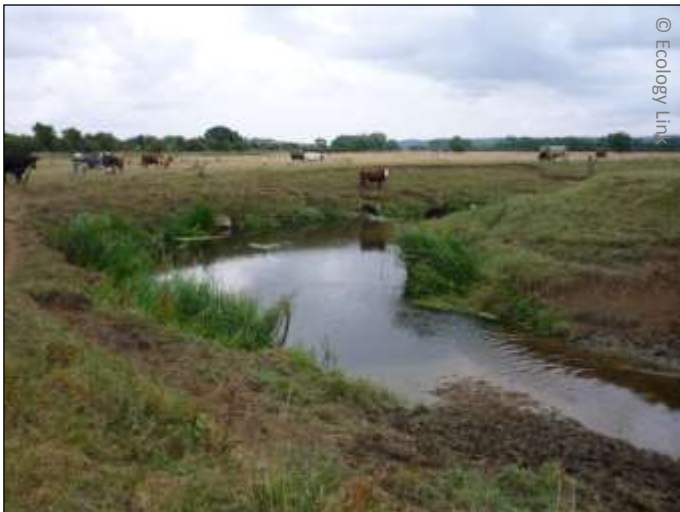
Fig 1. Erosion around the meander

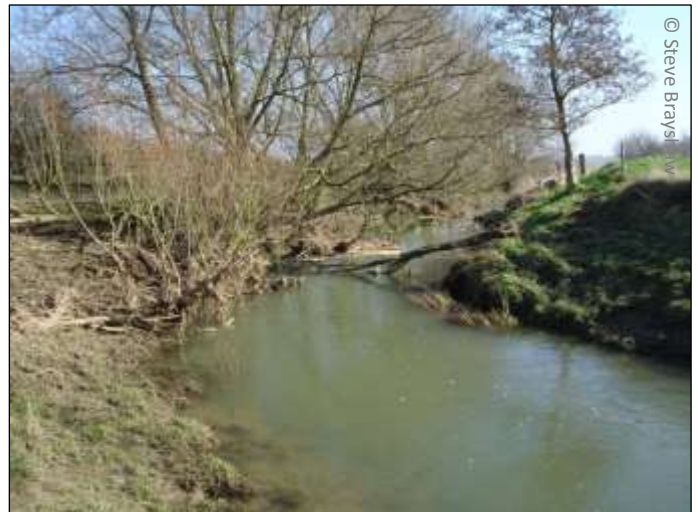
Fig 2. Unsecured woody debris

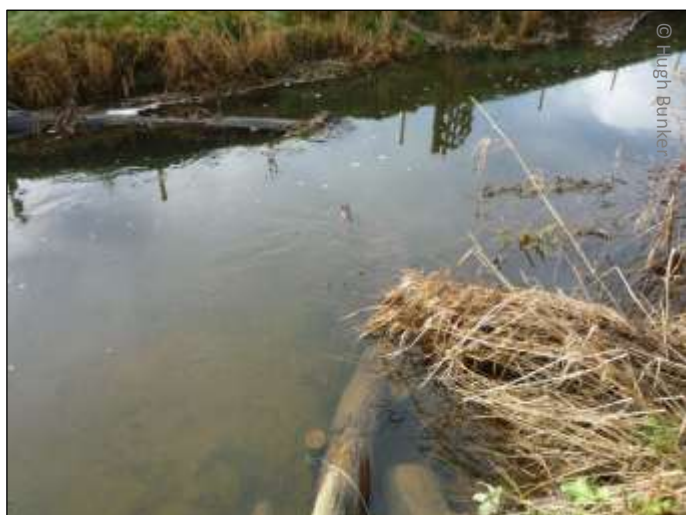
Fig 3. Woody debris deflector

Faggot bundles, woody debris and coir roll deflectors have been used to increase localised flows. All the deflectors point upstream to reduce the potential for bank erosion. Offset (alternate) deflectors have been used to encourage meandering and paired deflectors have been used to encourage pool and riffle development. Gravels have been introduced around some of the deflectors to accelerate the development of new riffles (see below).

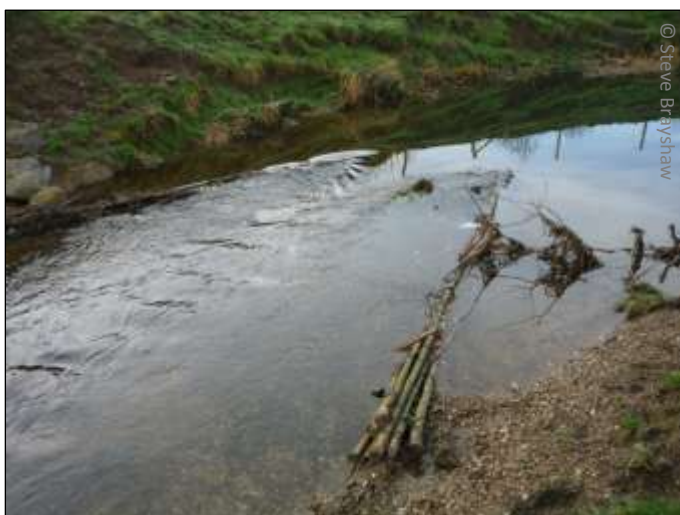
Fig 4. Faggot deflector

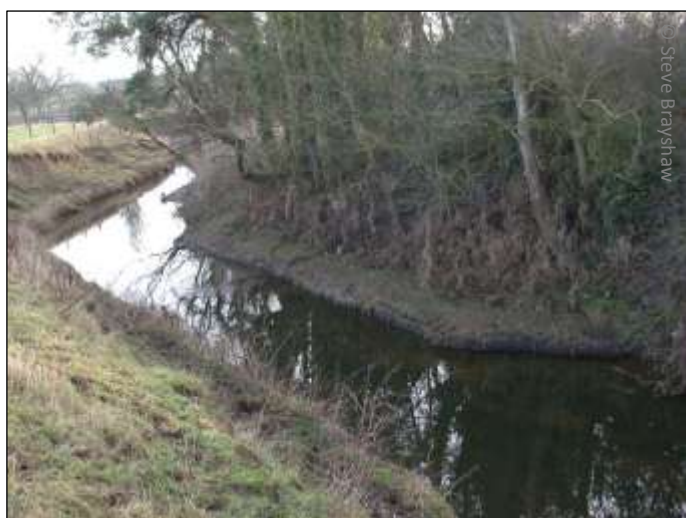
Fig 5. Earth-filled faggot and coir pinching

Wider, less vegetated sections have been narrowed by the provision faggots, woody debris and/or coir rolls. Some “pinches” have either been backfilled with woody debris, brash or earth excavated during the construction of the cattle drinkers, whilst others have been left unfilled. The unfilled enclosures will gradually fill with trapped silt and eventually a consolidated wetland margin will develop. Some of the coir rolls were pre-planted to encourage a more rapid development of marginal vegetation.

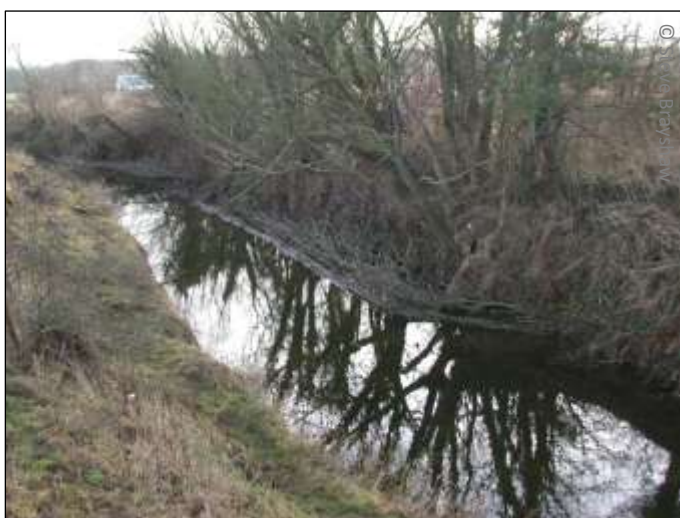
Fig 6. Faggot pinching back-filled with brash to trap silt

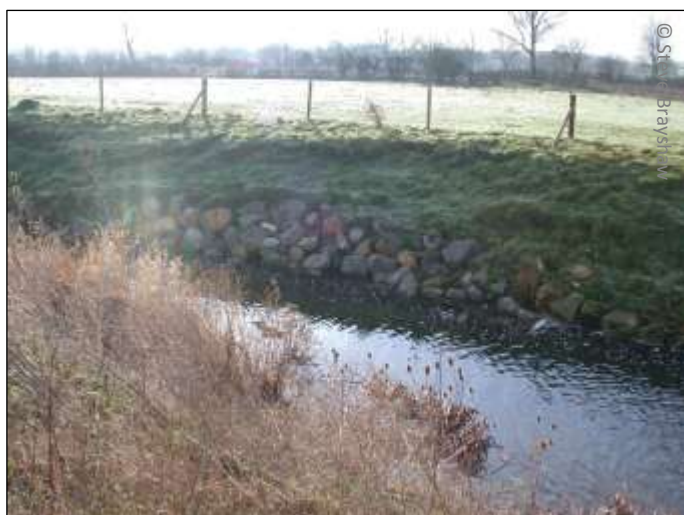
Fig 7. Large rock bank toe protection

Short sections of bank, where erosion was most severe as a result of undercutting during high flows, have been protected using large stone revetment. Elsewhere coir rolls, some of which have been pre-seeded/planted, have been used to control erosion at the toe of the bank and encourage rapid establishment of marginal wetland vegetation. In one location a length of re-profiled bank, consolidated behind a length of coir rolls, was planted with common reed.

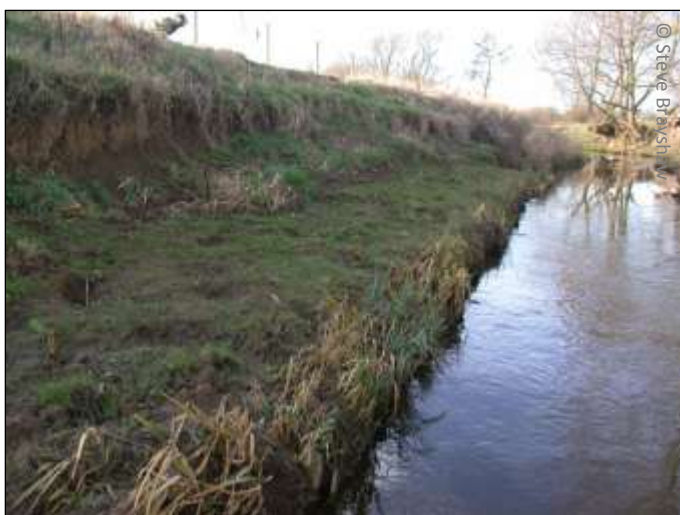
Fig 8. Pre-planted coir bank toe protection backfilled with earth

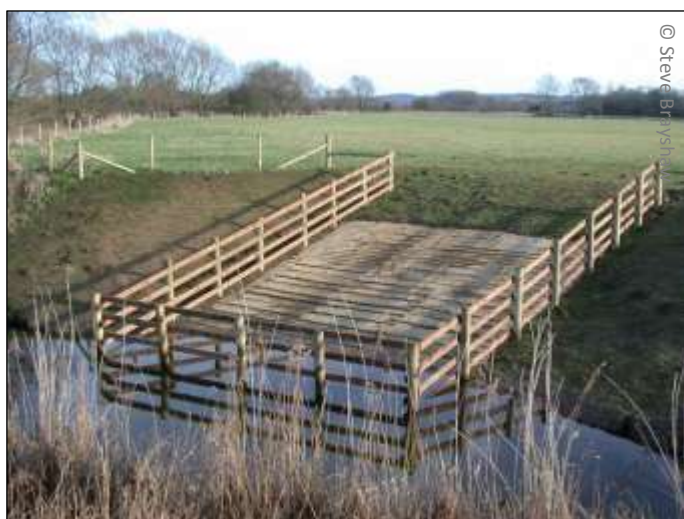
Fig 9. A typical cattle drinker

The river has traditionally been used to provide drinking water for livestock and this has caused widespread and, in places, severe localised erosion. To reduce this impact new cattle drinkers have been installed in each of the fields adjacent to the river. A drinker has also been installed on the eastern side stream which is introducing a heavy silt load near the bridge at the downstream end of the reach. As the river banks were high and steep a significant amount of earth was excavated during the construction of the drinkers. However, all the excavated material has been used to backfill the enclosures created to pinch the channel (see above).

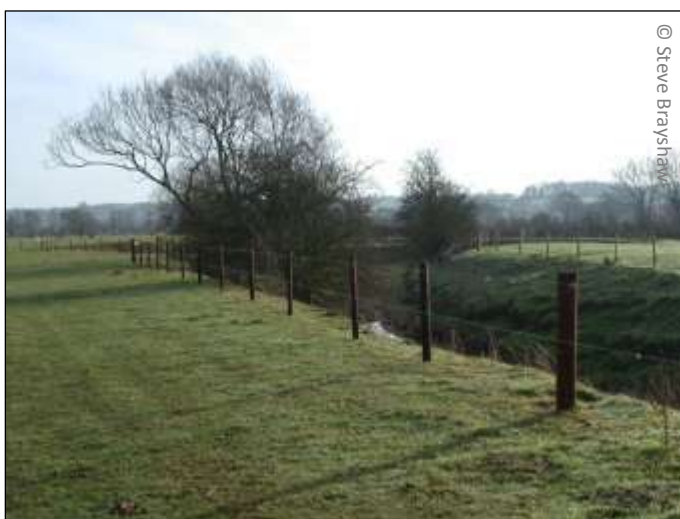
Fig 10. The typical stock fencing pattern

The majority of the left (northern) bank was fenced by the landowner, using wooden posts and 2 lines of barbed wire, immediately prior to the implementation of the scheme to exclude livestock from the river banks and channel. Additional fencing to the same specification has been erected on the right bank as part of the scheme. The fencing will significantly reduce bank erosion and slumping and enable the stabilisation of existing exposed areas through colonisation by terrestrial vegetation. The exclusion of livestock will also allow more extensive marginal wetland vegetation to develop, further consolidating the toe of the bank. Controlled light grazing of the fenced areas to prevent the development of rank grassland and scrub will be possible when ground conditions are suitable.

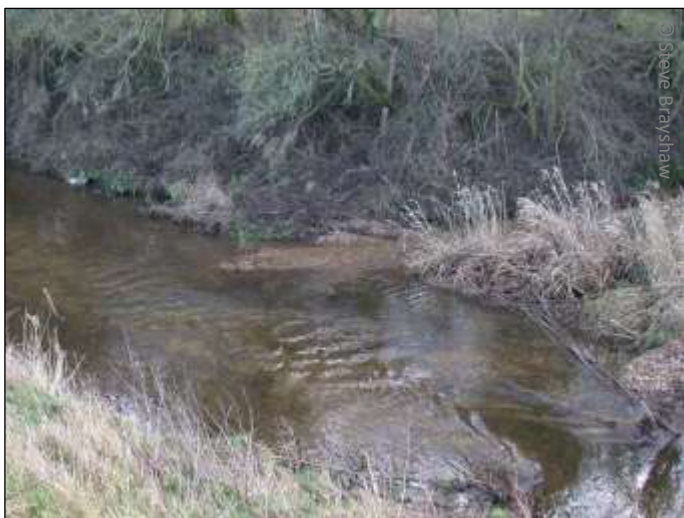
Fig 11. Gravel placed in the mouth of the tributary

Although the majority of the reach has a gravel bed, mixed gravels between 10 and 40mm in diameter have been introduced in places to create and enhance existing runs and riffles. These gravels also provide improved opportunities for spawning fish and habitat for invertebrates. Gravel has also been placed in the mouth of the most easterly tributary stream to provide an off-channel spawning area. Whilst the gravels were placed carefully they will naturally move downstream and modify the channel in response to changing flows.

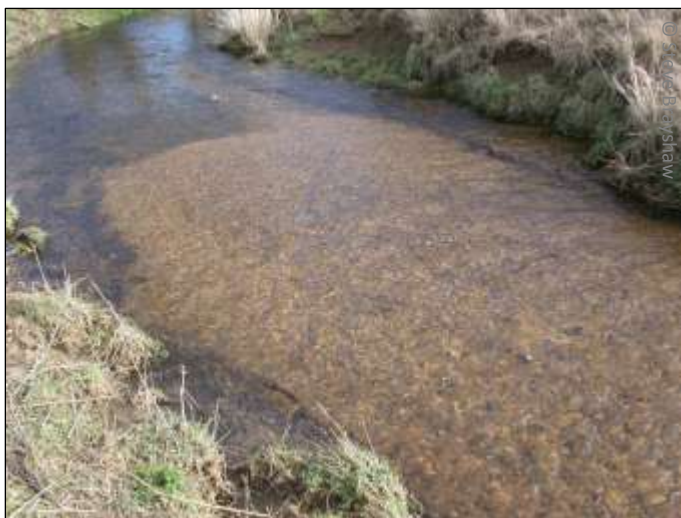
Fig 12. A new gravel riffle

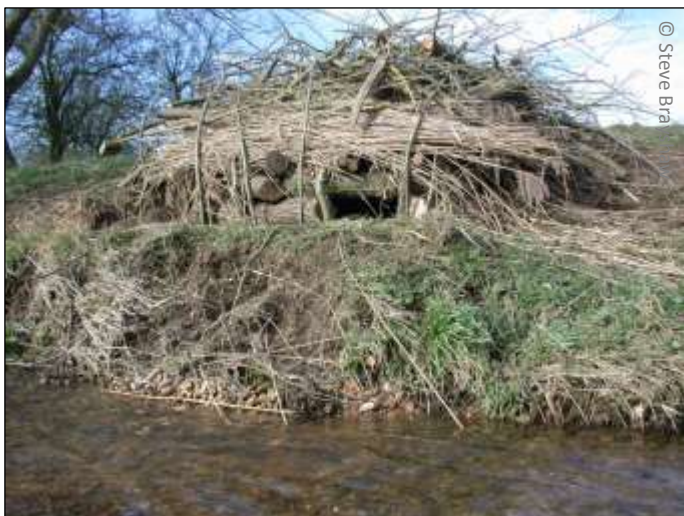
Fig 13. Otter holt constructed by Moulton College students

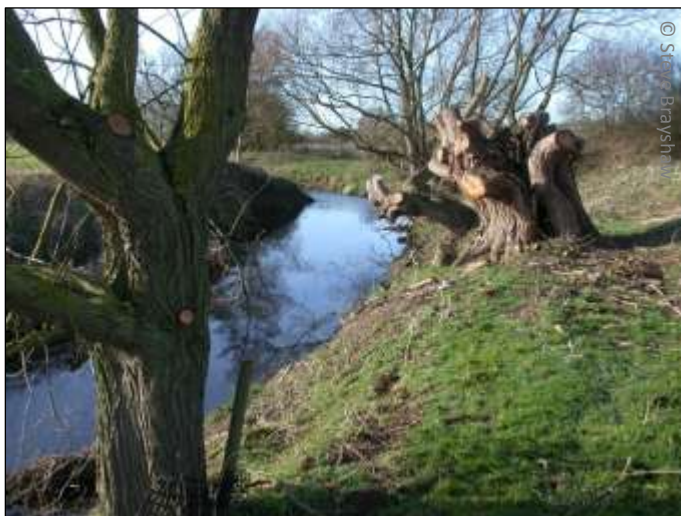
Fig 14. A repollarded willow

There are individual trees and some denser sections of scrubby woodland on the banks and in places large limbs have fallen, some still partially attached, in to the river. This woody debris is providing natural channel pinching in places, but this has potential implications for flood defence. Excessive amounts of woody debris has been removed and used to provide flow deflection and channel pinching; collected into piles to provide additional deadwood habitat; and some of the larger material has been used to construct an artificial otter holt. Several larger willows have also been re-pollarding to avoid future collapse. Ecology Link recommended a 10-20 year rotational pollarding programme, which would also include the pollarding of young and maturing trees for the first time, to provide a mix of maiden and pollard specimens along the length of the river.

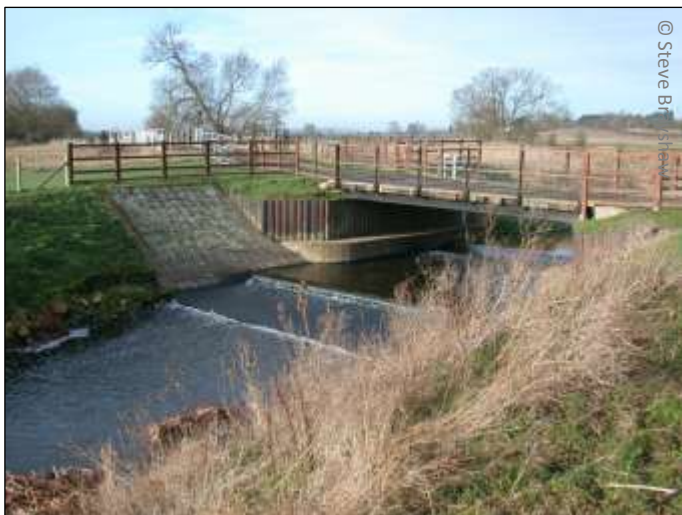
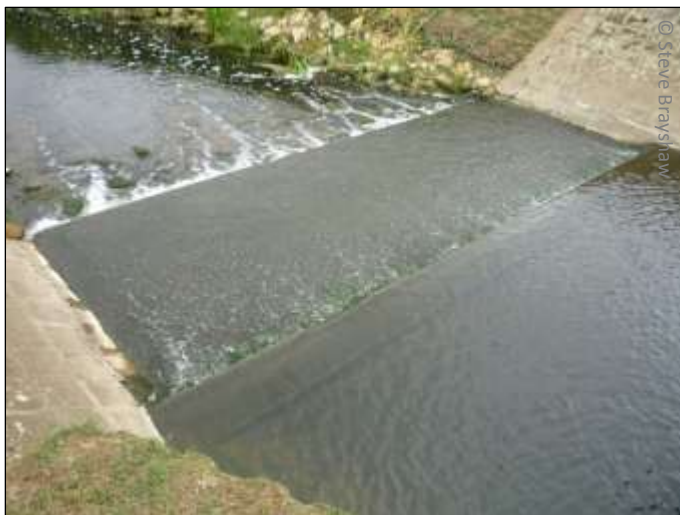
Fig 15. Ashley Gauging Weir is a barrier to fish and eel passage

A fish and eel pass is required at Ashley Gauging Weir.

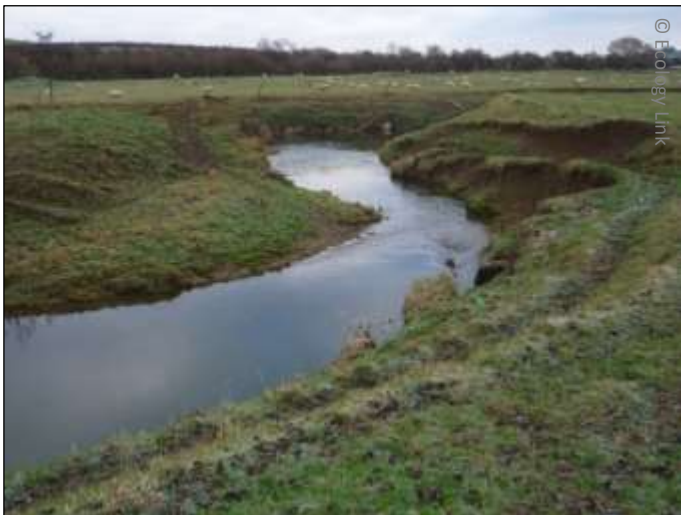
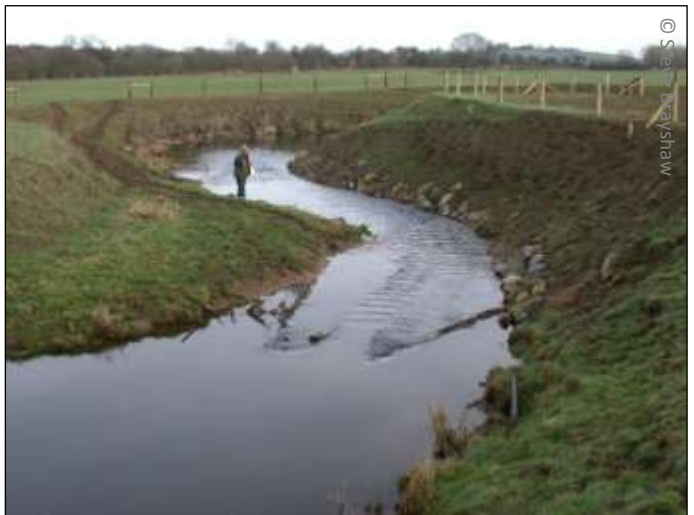
Fig 16. The meander before and after, showing new paired faggot deflectors, bank stabilisation and fencing

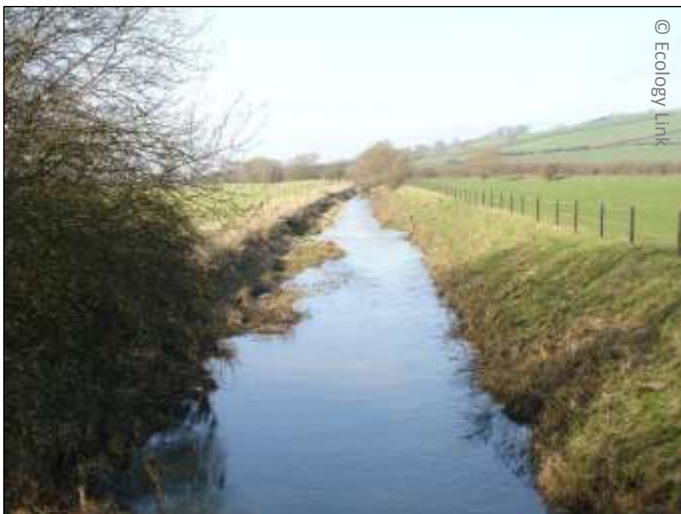
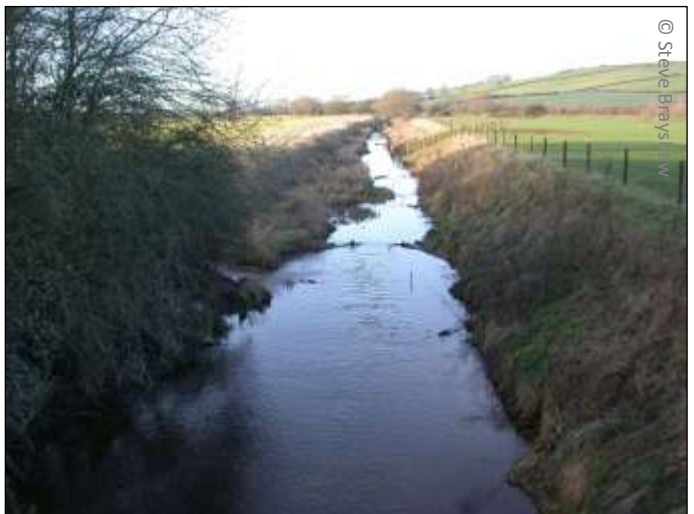
Fig 17. The straightened downstream section before and after, showing the series of deflectors and the new drinker
