ARCHAEOLOGICAL
SERVICES
DURHAM UNIVERSITY

Weir Removal Project
Ennerdale Mill
Egremont
Cumbria

archaeological monitoring

report 4826
July 2018

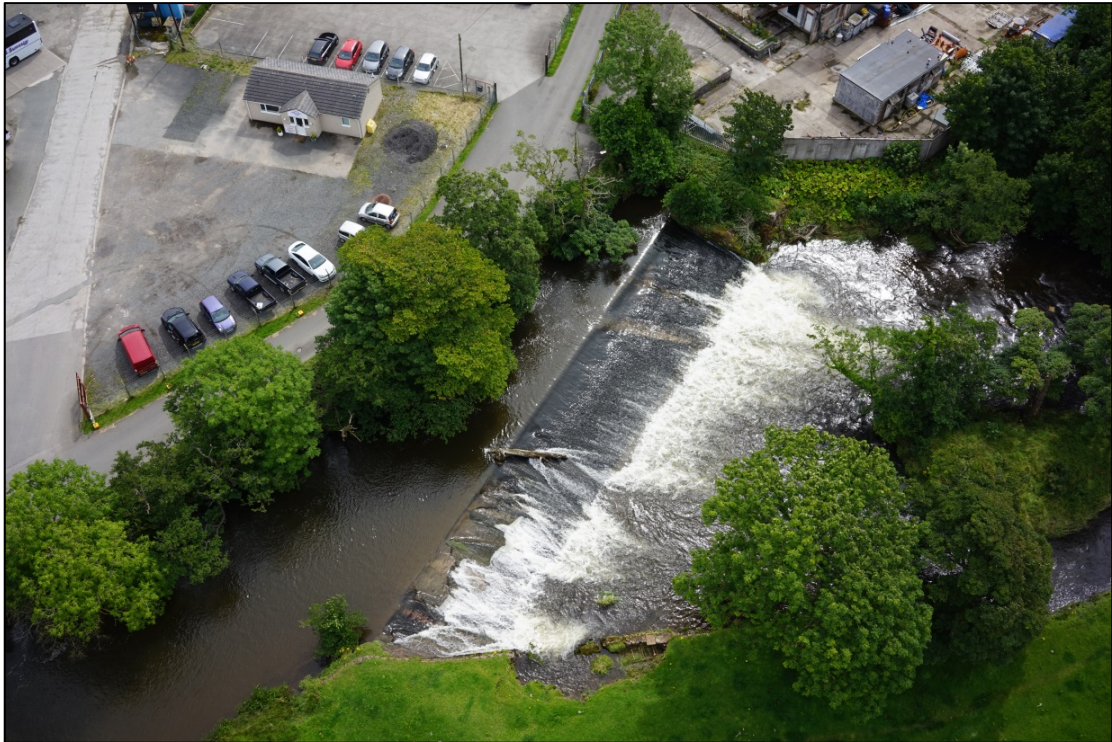
- 5.2 The weir had been covered by concrete and a poured concrete wall created at the front (east side) of the weir during the 20th century (photo 1, Unmanned Aerial Vehicle photograph). The concrete was reinforced by metal stakes placed at intervals through the concrete before it set. In places this concrete had started to fail, revealing the original structure of the weir.

Photograph 1: The concrete-covered weir, looking north

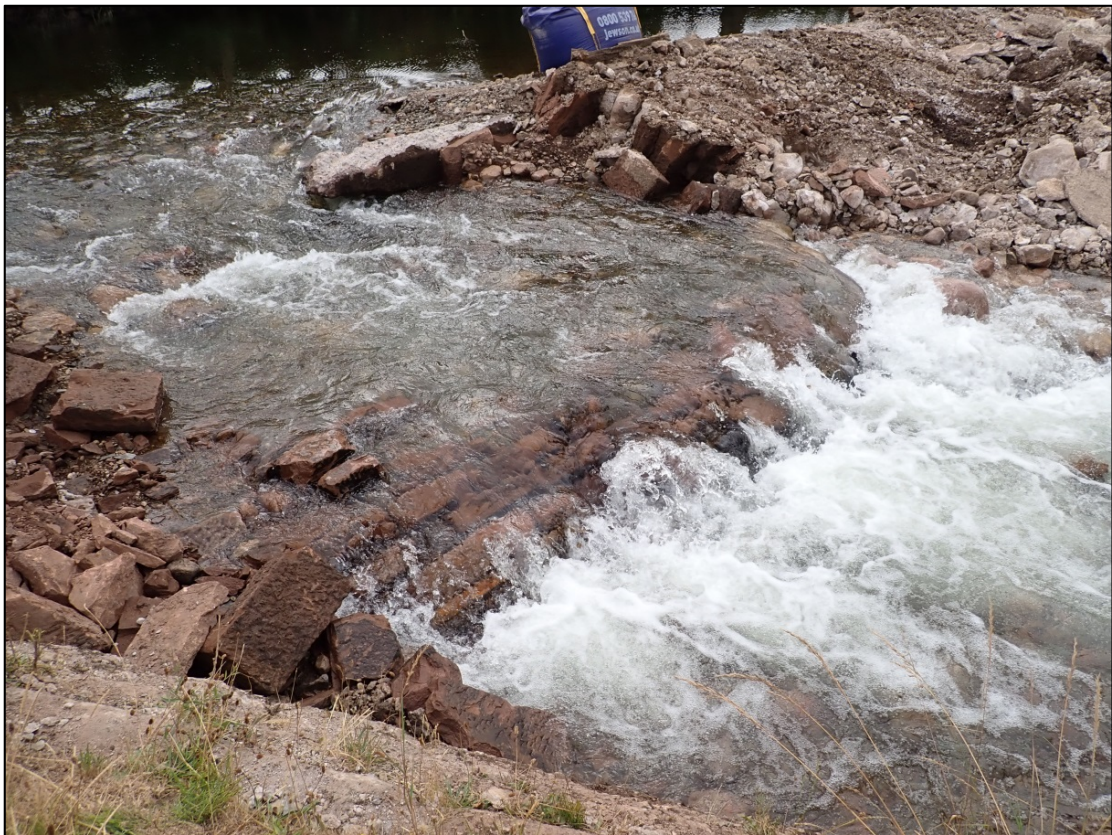
- 5.3 After the removal of some of the concrete a notch was made in the north end of the weir to reduce the water level in front of the weir. This part of the weir was constructed from rectangular, hewn and worked blocks of locally quarried St Bees sandstone, some up to 0.7m wide (photos 2 and 3). Timber planks (photo 4) held in place by large timber stakes (photo 5) had been placed along the front and rear of the weir and the sandstone blocks had been placed on edge between the wooden supports to form the body of the weir (photo 6). To create the slope the west end of the weir was two blocks high tapering down with varying size blocks until it was one block high at the east side.

Photograph 2: Notch cut through the weir, with lower course of sandstone visible under water and upper course visible in section, looking south

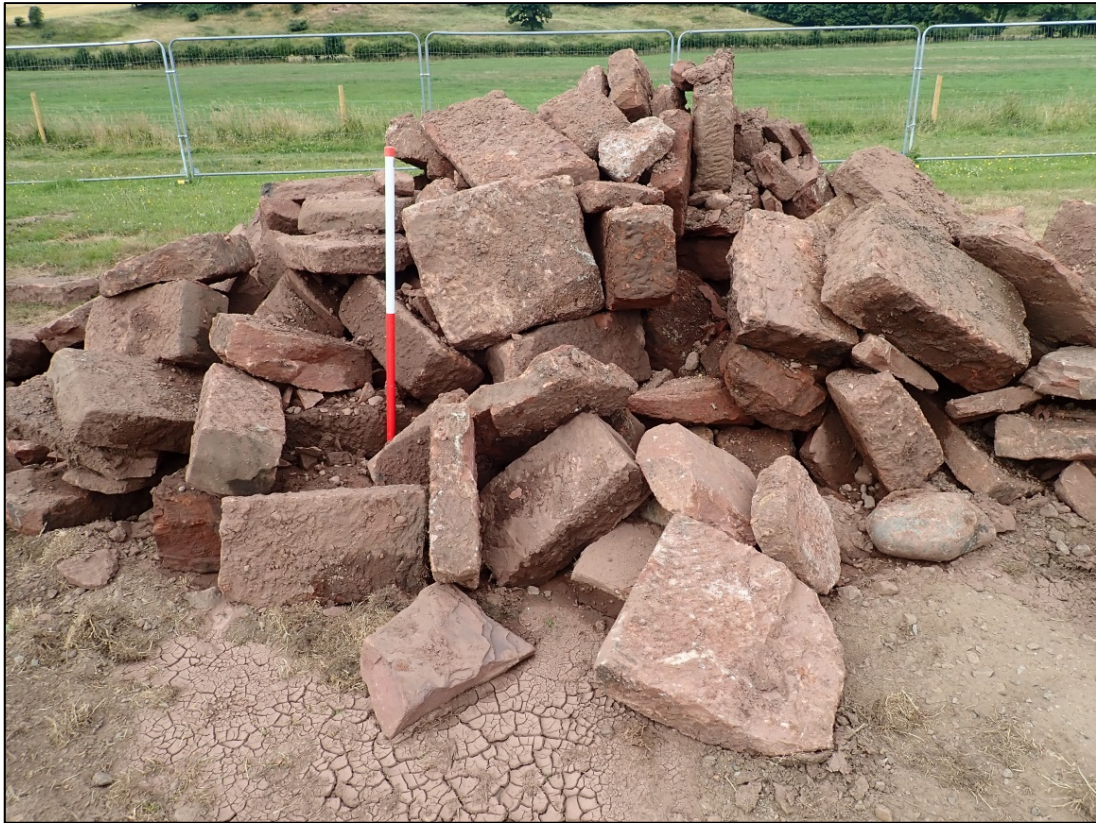
Photograph 3: Stone removed from the weir

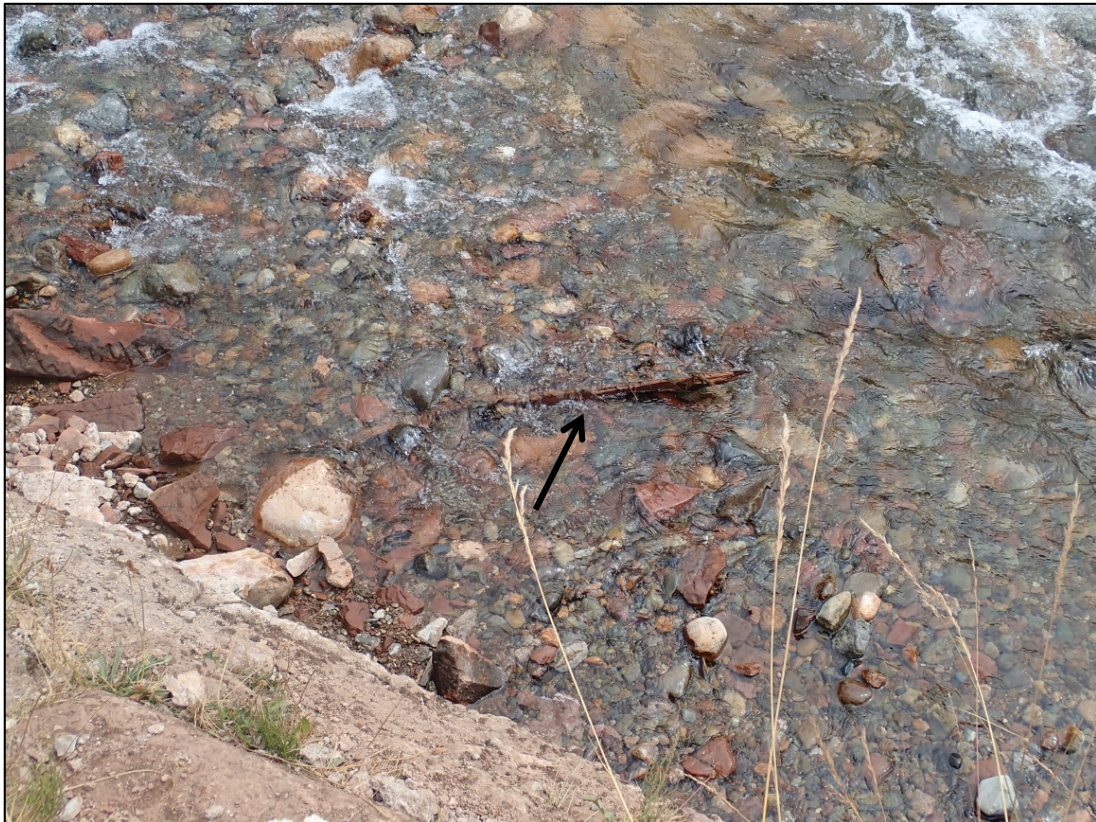
Photograph 4: *In situ* wooden plank at the north end of the weir, looking south-east

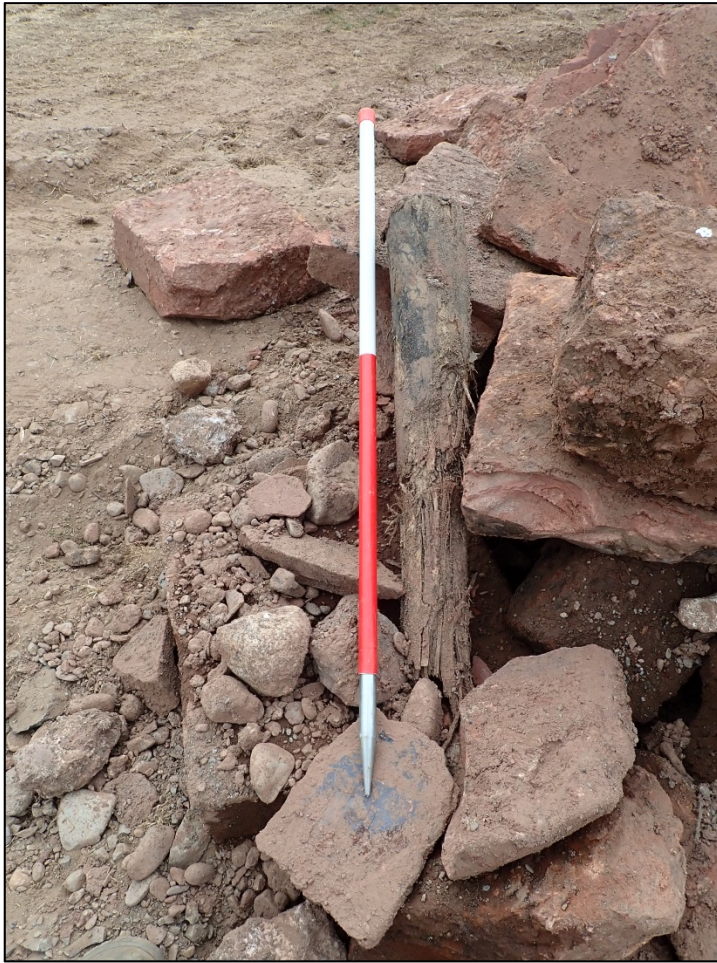
Photograph 5: Wooden stake removed from the weir

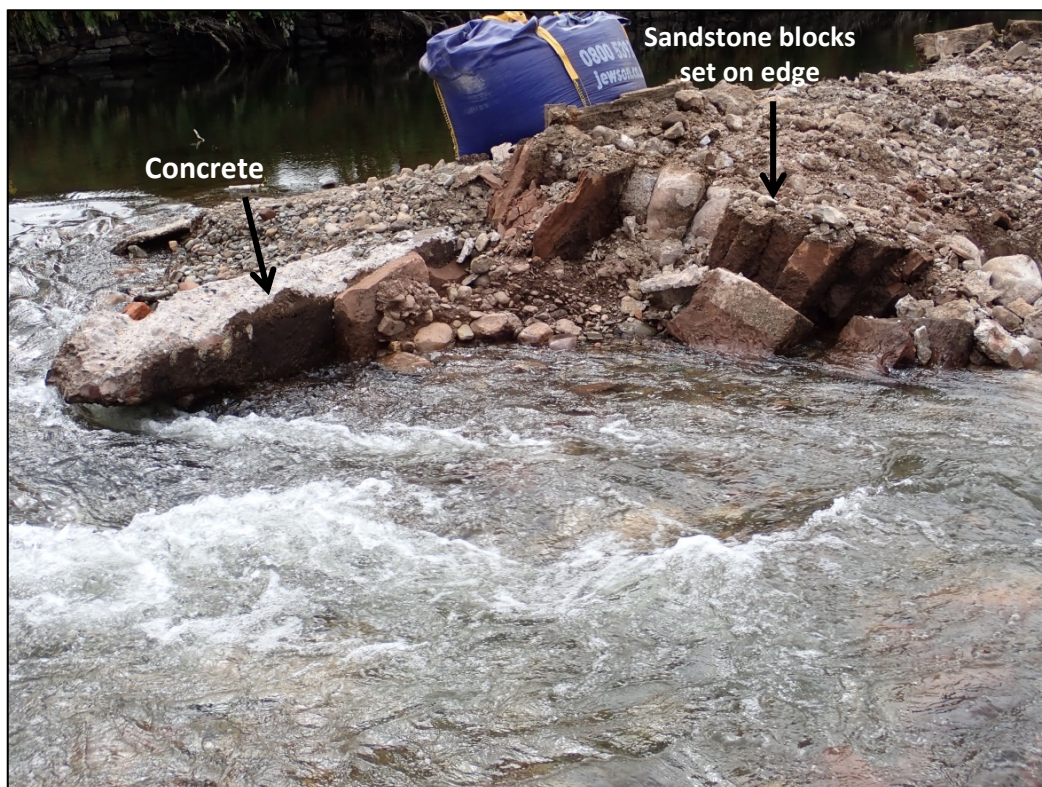
Photograph 6: Detail of section through the weir, looking south-east

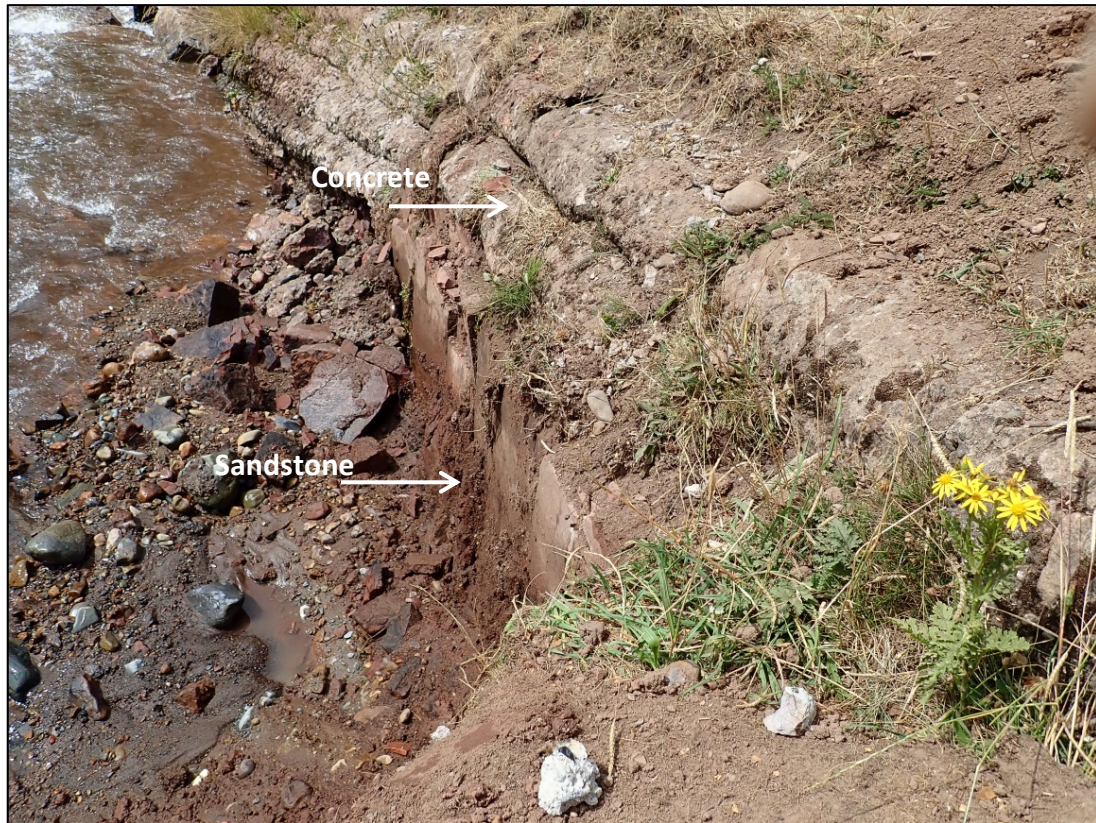
- 5.4 The river bank along the north edge of the weir had been reinforced with more upright blocks of sandstone set into the riverbank (photos 7 and 8) forming a wall. The sandstone blocks from the weir were sat against this wall of sandstone (photo 9). The bank had been later reinforced with sandbags filled with concrete and left to harden to form a wall. The same concrete sandbag construction method had been used to reinforce the east bank of the river.

Photograph 7: Sandstone and concrete bank reinforcement, looking south-west

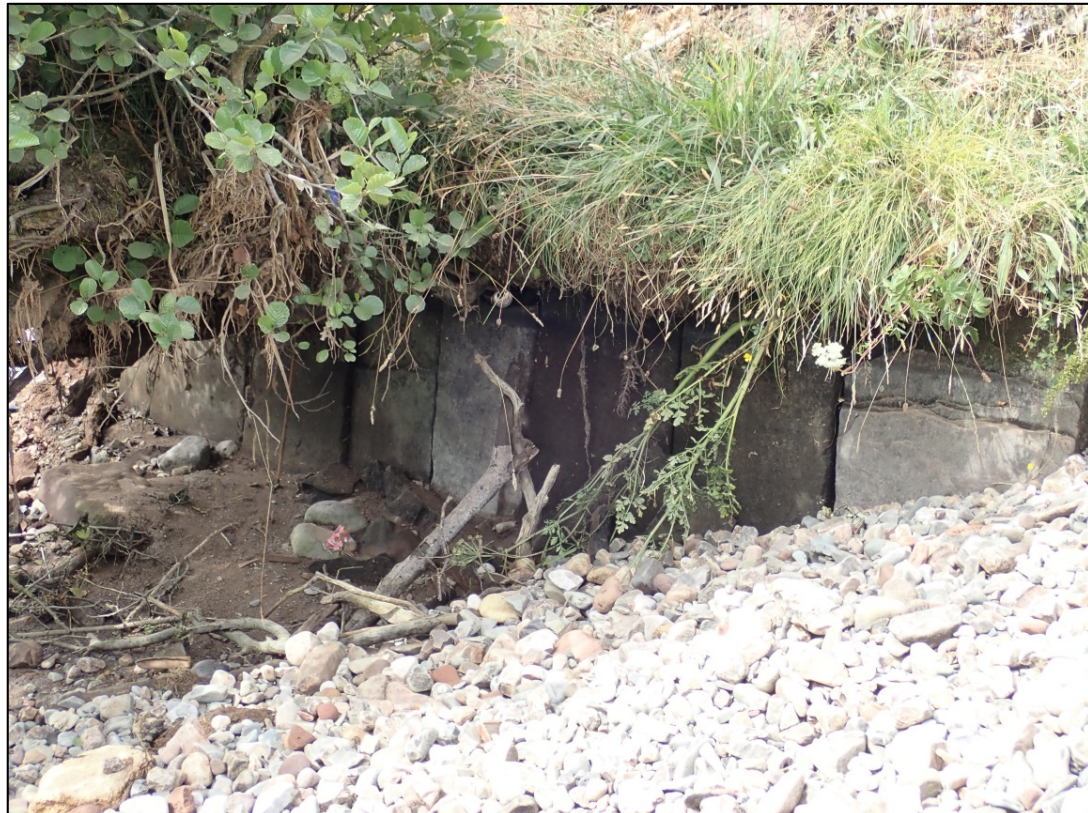
Photograph 8: Sandstone riverbank reinforcement, looking west

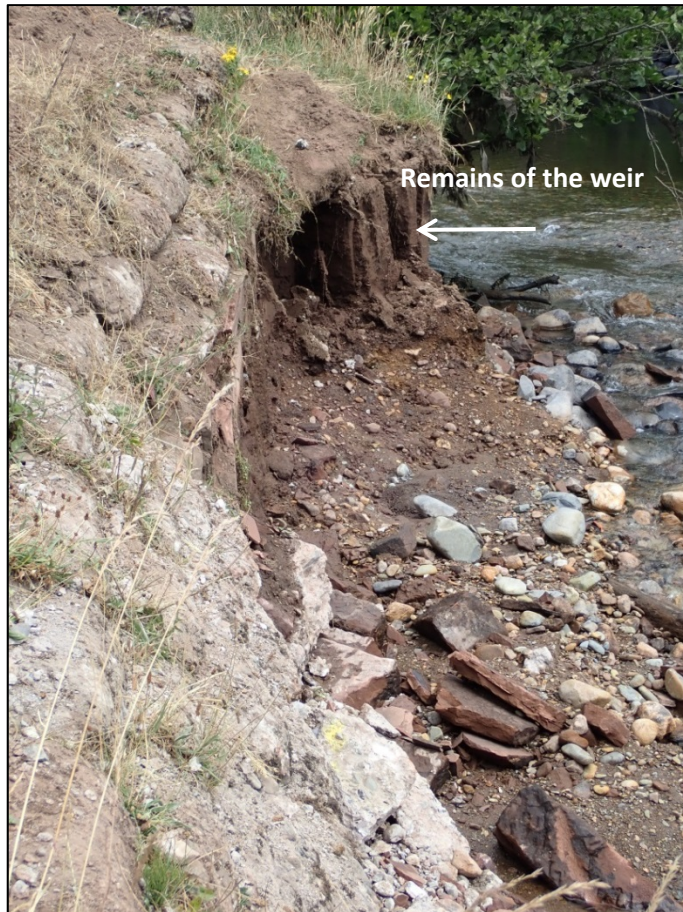
- 5.9 From this it would appear that the sandstone blocks that formed the north part of the weir were a later addition and not part of the original construction. As they sit in the fast flowing part of the river it is likely that a historic flood event had damaged this part of the weir and the riverbank resulting in the need for a repair and the reinforcement of the riverbank.

Photograph 9: The remains of the sandstone part of the weir, sat against the bank reinforcement, looking north-east

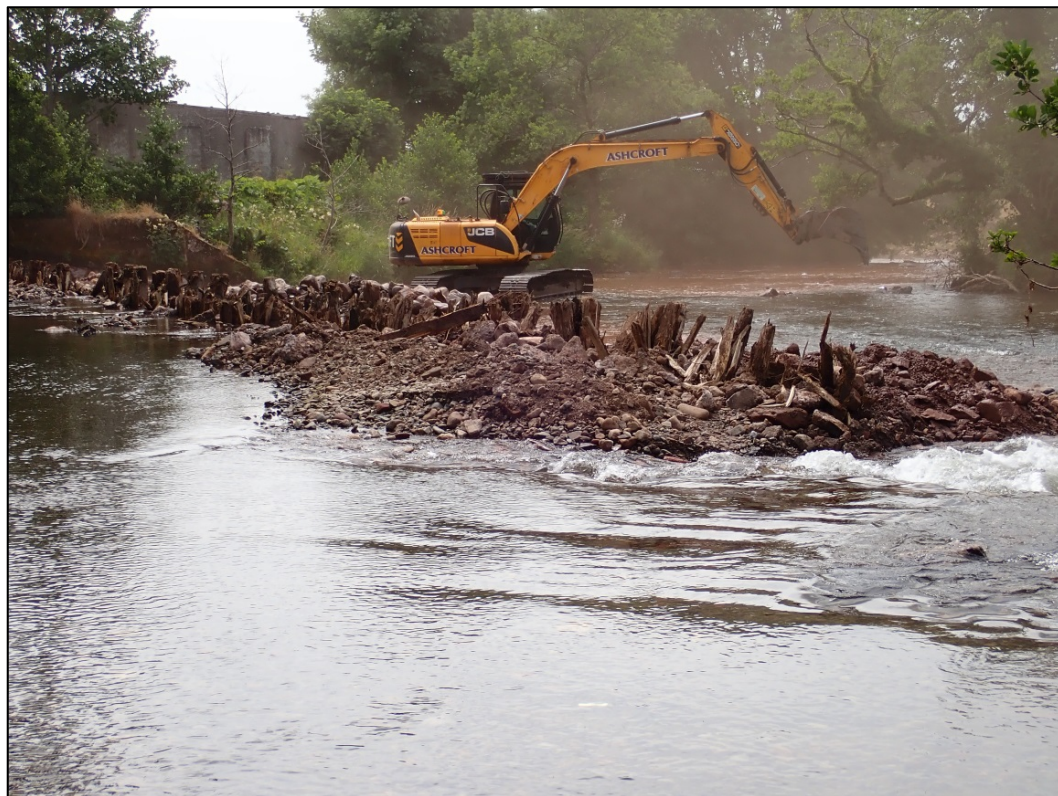
- 5.5 To the south of the sandstone the construction of the weir was different. Here large timber uprights have been piled into the riverbed at intervals of approximately 1m (photo 10). Wooden planks had been placed upright between the larger timbers and held together by cross-beams. This structure would have created an effective dam to the river to allow the construction of the weir.

Photograph 10: Upright timbers and planks forming the front (east side) of the weir, looking south-west

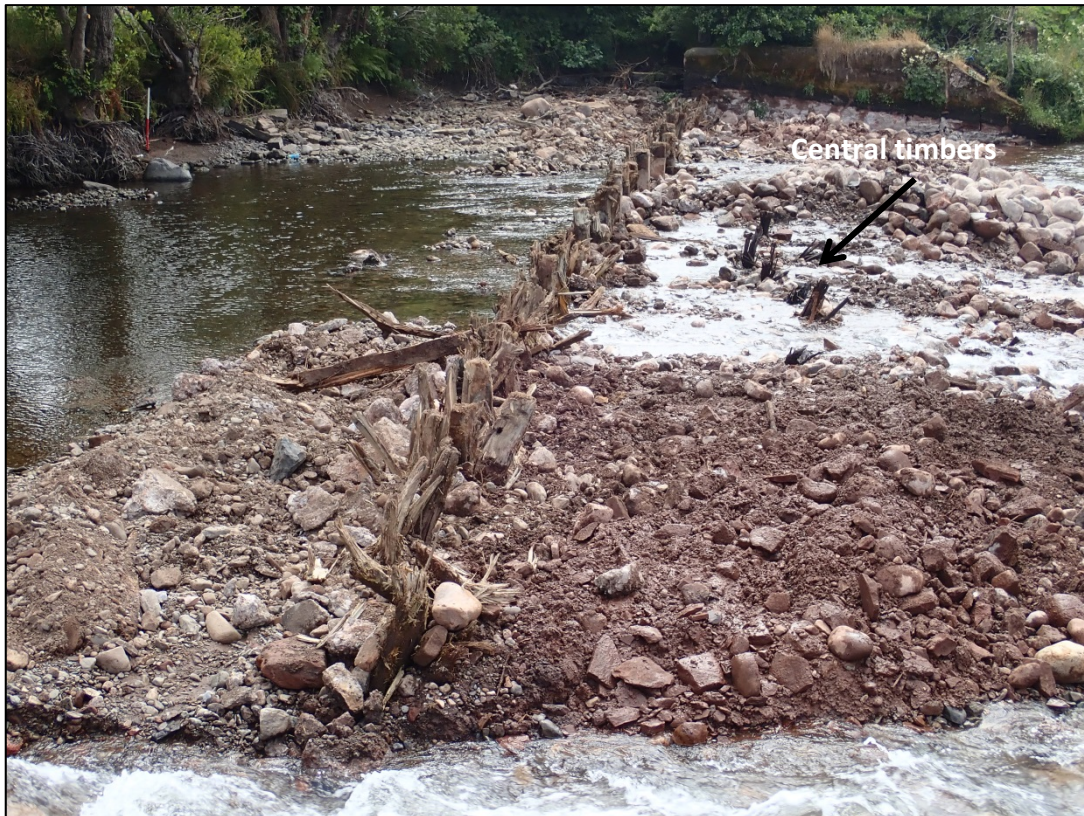
- 5.6 Along the centre of the weir a second line of wooden uprights was recorded, smaller than those at the front of the weir (photo 11). Large wooden planks ran east/west across the weir between the uprights dividing the area into sections. At the rear (west) side of the weir shorter smaller wooden stakes were piled into the river bed with long planks placed on edge between them to form the back of the weir (photo 12).

Photograph 11: Front upright posts and remains of central upright posts, looking south

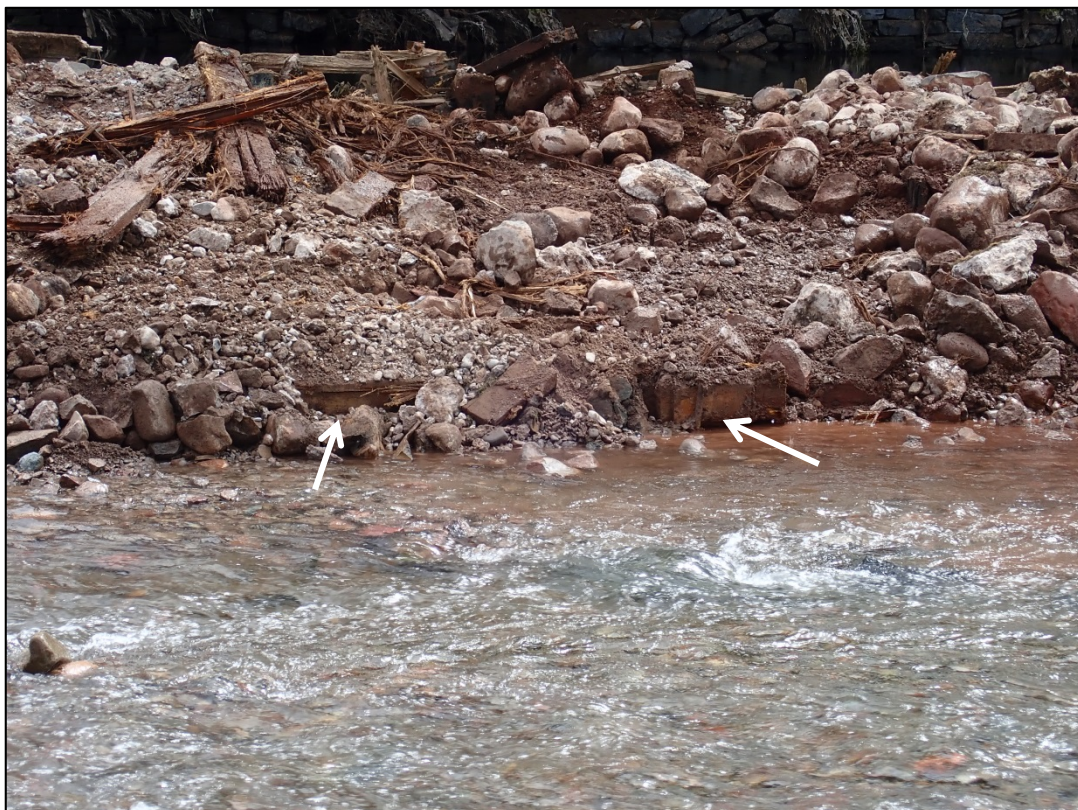
Photograph 12: Planks set on edge forming the rear (west side) of the weir, looking east

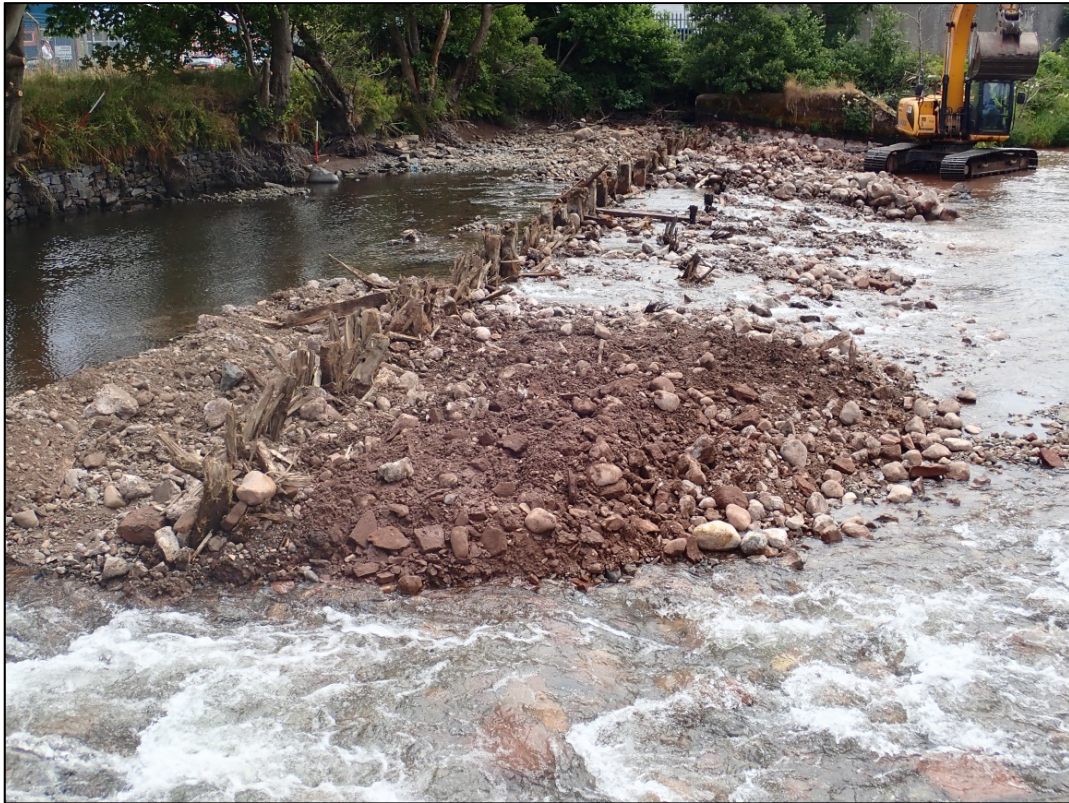
- 5.7 This construction method would have created a series of boxes between the upright timbers. These boxes have then been filled in with gravel and small cobbles (photo

Photograph 13: Gravel and smaller cobbles forming the main body of the weir, looking south

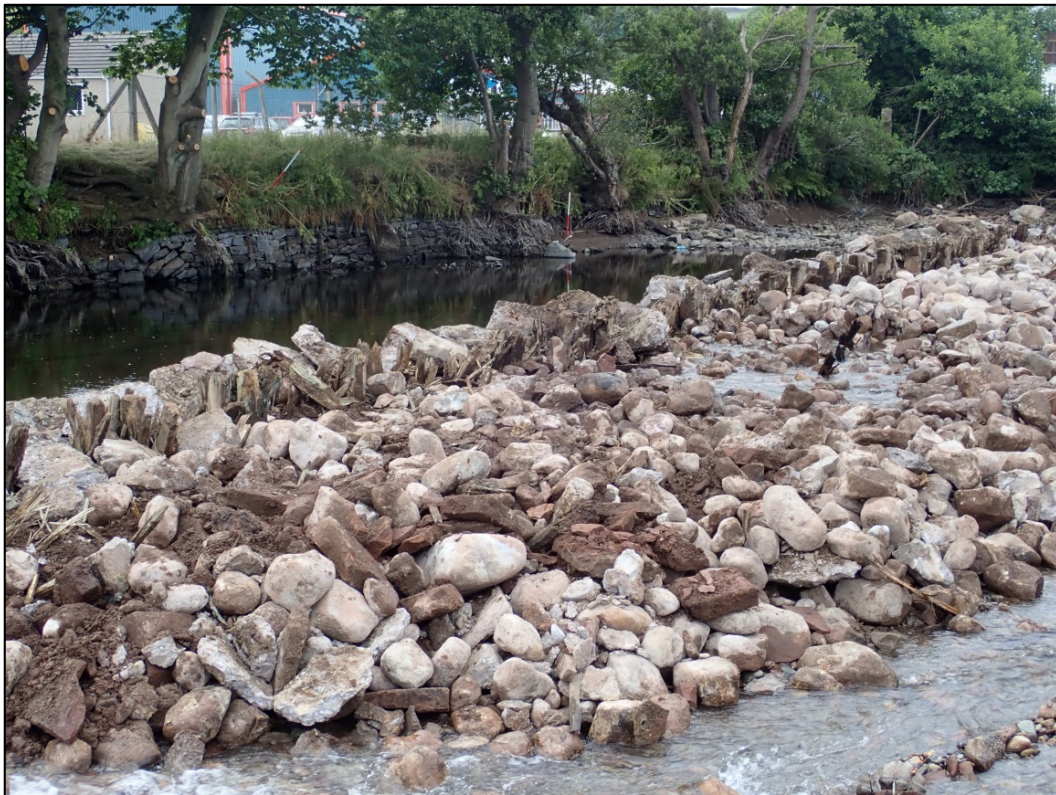
13) with large river cobbles filling the top of the structure and forming the surface of the weir (photo 14).

Photograph 14: Cobbles forming the surface of the weir (disturbed by the removal of the modern concrete), looking south-east
