Whitemills Backchannel

Location: Whitemills, Earls Barton

Summary of activities

The Whitemills Backchannel scheme comprised of 4 activities. The activities were:

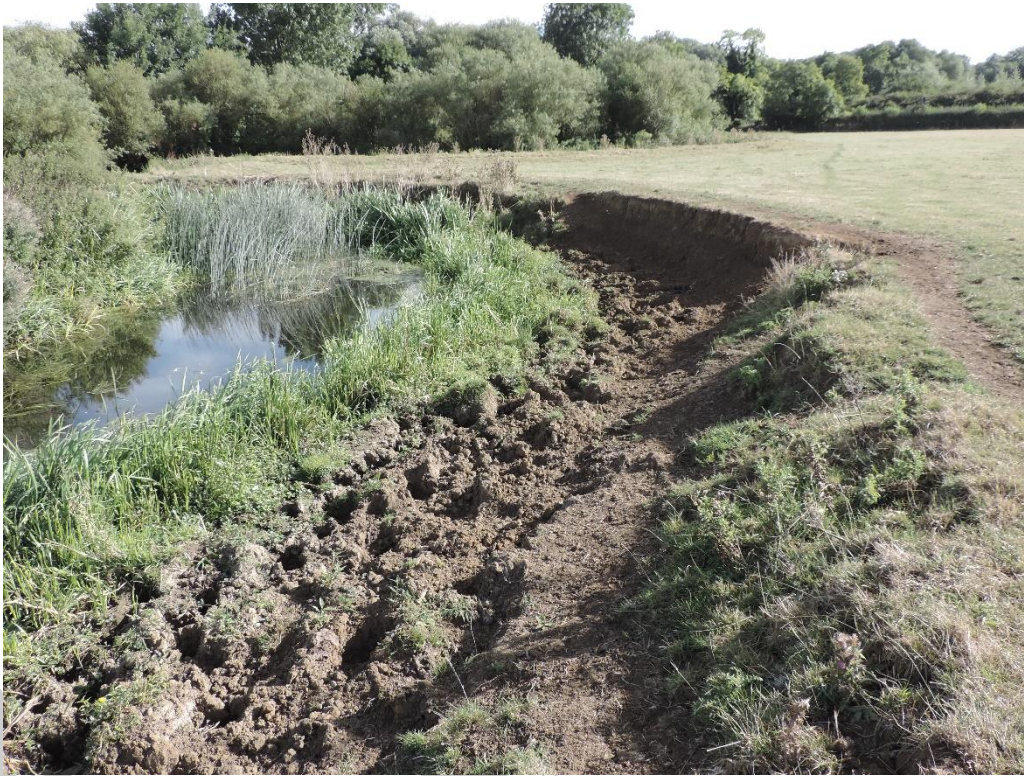
The banks of White Mills Lock Back Chanel had been severely damaged by cattle poaching and this resulted in significant fine sediment inputs to the River Nene. The primary purpose of the proposed works was to repair the eroded banks, prevent further erosion and improve marginal wetland habitat. Tree planting and tree management would enhance riparian and instream habitats with the bank re-profiling improving conveyance. Figure 1 is a map of the area where Whitemills back channel is and highlights the area where work was completed. Figure 2 shows the condition part of the back channel was in prior to the project being completed. It is clear to see the impact the cattle had whilst grazing on the bank. Due to grazing the bank had collapsed, erosion rate had increased, and the channel was widened. This also meant that lots of sediment was entering the backchannel, impacting the quality of the in-stream habitat.

Figure 2 Extent of poaching before the project

Using a 360° tracked excavator with a suitable reach, the steeply eroded banks were re-profiled to form a stable slope behind a wet berm on which a fringe of wetland vegetation can develop naturally. A berm is a flat strip of land, raised bank, or terrace bordering a river. During on-site consultation with the local Environment Agency Asset Performance Officer it was noted that for some time now, the Environment Agency has been planning to undertake works to improve conveyance and increase channel capacity immediately upstream of the culverts under the road at the bottom of the restoration reach. So, at the Asset Performance team’s request, it was agreed that this project will take this extra work in partnership with the EA while suitable machinery was available on site. The additional works formed part of the bank re-profiling activity whereby the height of the land enclosed by the meander at the downstream end of the reach was reduced to 30cm above normal water level in the back channel.

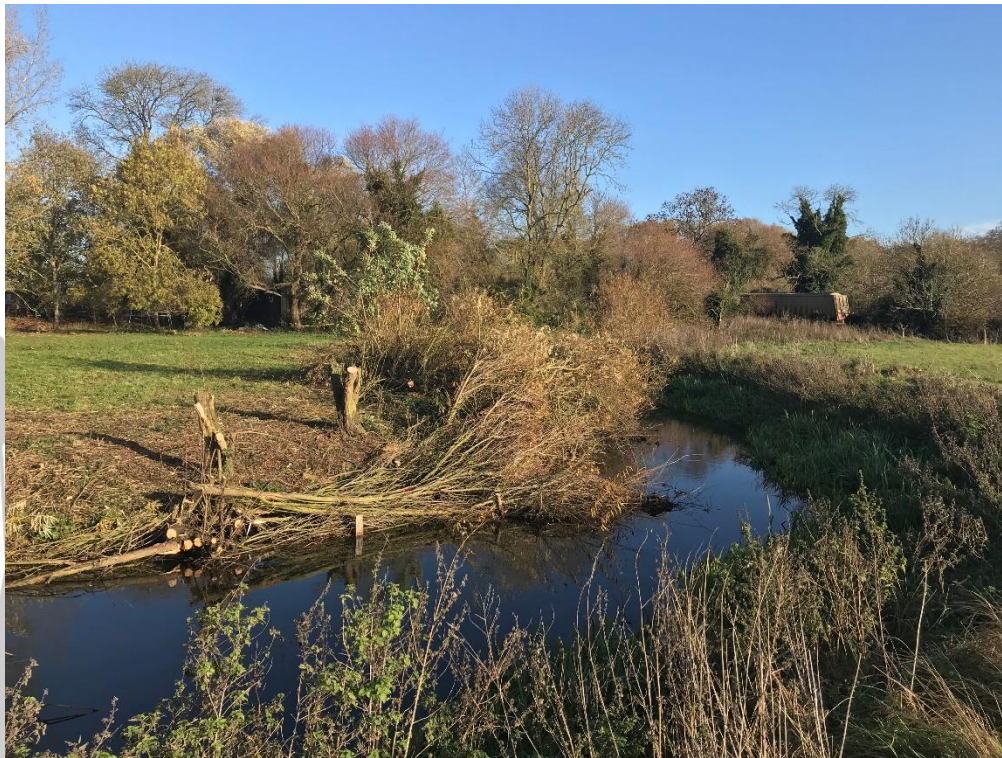
This is where large limbs or whole small trees have a notch cut into the base of the trunk (a hinge) and are dropped on to the bank or into the water in a controlled way before being pinned into the bank using hardwood stakes and heavy-duty wire. This technique was carried out twelve times across the back channel to increase woody habitat, providing refuge for juvenile fish such as Chub and invertebrates as well as birds and mammals throughout the year. Figure 3 shows one of the fifteen trees that were hinged and pinned in to the back channel.

Figure 3 Hinging and pinning at Whitemills

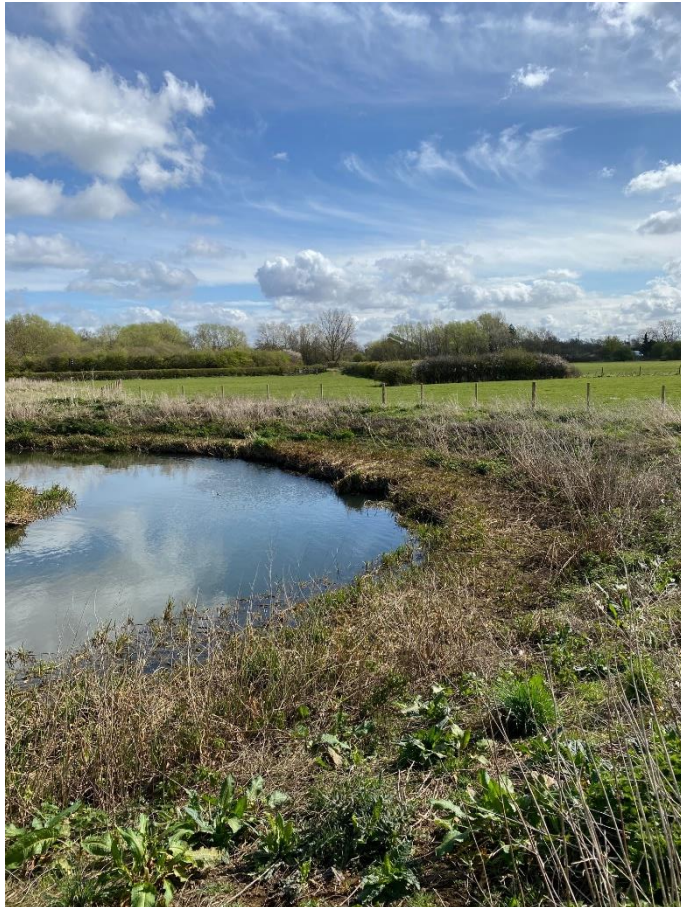
Topsoil was stripped and stockpiled for replacement after the re-profiling was completed. The arising sub-soils were used to infill a low area in the field and to reconstruct the earth bund on an alignment further south on the existing high ground. Following the replacement of the topsoil the area was grass seeded to restore the grass lost during the regrading. A single small tree, which was in poor condition, was removed to facilitate this operation, but additional planting further upstream will mitigate this loss.

Figure 4 Regraded banks at Whitemills 16 months after completion
