Nassington Backchannel

Location: Nassington, Peterborough

Summary of activities

The Nassington Backchannel scheme comprised of 5 activities. The activities were:

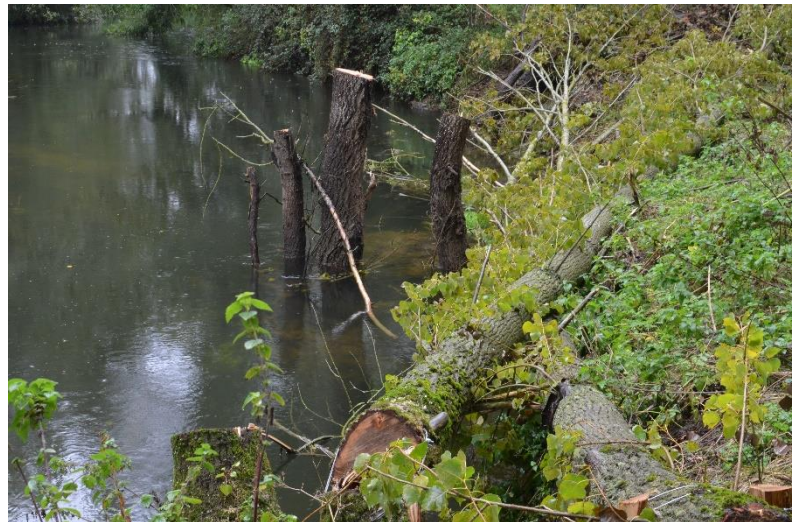
Figure 2 – Secured limbs on the bankface extending on to the channel

The trunks of trees were partially cut at the base, leaving a narrow bark and sapwood hinge, and then bent horizontally (pointing downstream) along the bank to create a tangle of twigs and branches extending to no more than 10-15% of the channel width. Cut limbs were held between pairs of hardwood stakes, and then secured with short loops of plain fencing wire attached to the stakes with staples. The loops of wire were independent from each other, so if one fails, the whole structure will not. Wire loops were twisted tight and the stakes driven down further to securely hold down the limbs in place. Post tops and surplus wire were trimmed to length. For added security, particularly if the hinge was to fail, in addition to the wire bindings, the limbs were drilled through and secured using lengths of steel cable shackled to double hardwood stakes driven deep in the riverbank using a mechanical (compressed air) post driver. Also, on the basis of advance maintenance, where trees have already collapsed, they were pulled against the bank and secured in situ, to ensure that they do not wash away in high flows and create a blockage downstream.

Post tops and surplus wire were trimmed to length. For added security, particularly if the hinge was to fail, in addition to the wire bindings, the limbs were drilled through and secured using lengths of steel cable shackled to double hardwood stakes driven deep in the riverbank using a mechanical (compressed air) post driver. Also, on the basis of advance maintenance, where trees have already collapsed, they were pulled against the bank and secured in situ, to ensure that they do not wash away in high flows and create a blockage downstream.

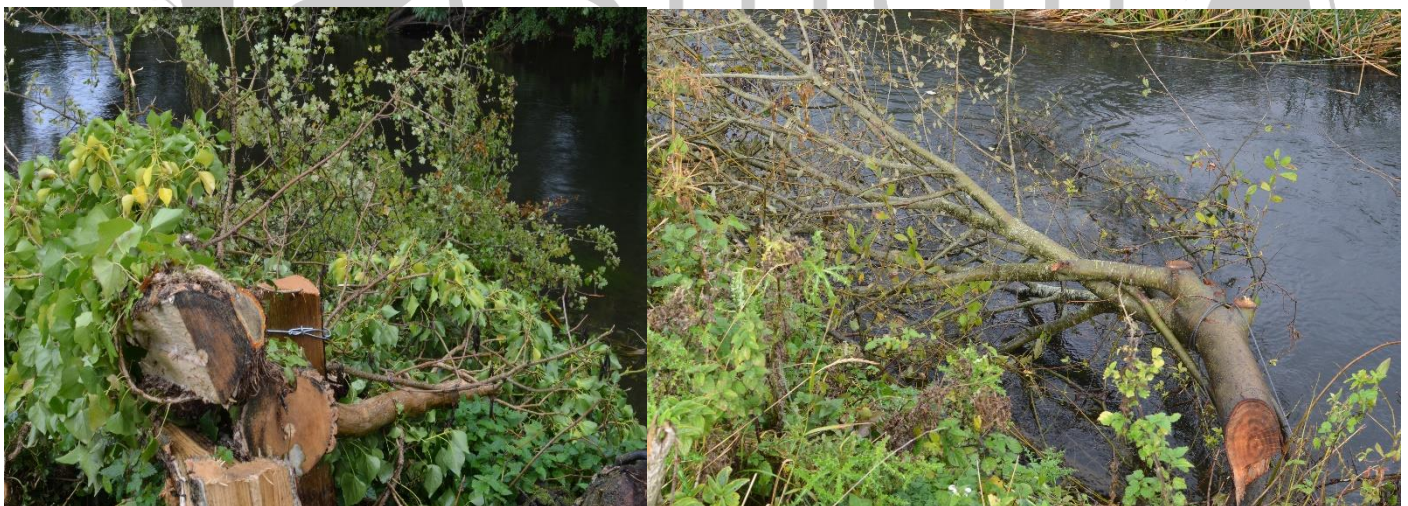
Figures 3 & 4 – Smaller hinged and pinned trees extending in to the channel

19 small trees as well as 2 large trees were selectively “hinged and pinned” to increase woody habitat and provide a refuge for juvenile fish and invertebrates. The limbs that were closest to the water and extended furthest across the channel at the time were selected to ensure that conveyance will be improved as a result of the works. Larger overhanging limbs/trunks were also selected on the basis that they were the most likely to collapse into the river with the potential to cause a blockage. As such hinging these larger 2 trees/limbs is effectively advance maintenance – removing the need for emergency action and ensuring that beneficial in-stream woody habitat is retained.

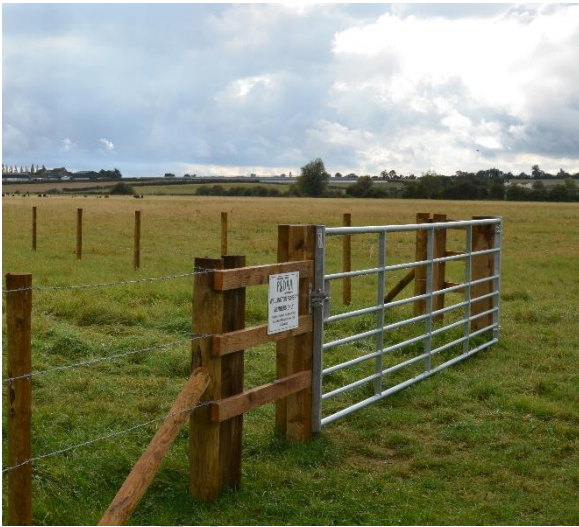
Figure 5 - Access gate on the new fence line

The left-hand bank from the weir at the upstream end of the back channel to the central point of the back channel had a dilapidated existing fence line, in places erosion had left the fence line suspended over the watercourse. The original fencing was replaced with post and 3 string barbed wire fencing, set 10m from the original fence line. The open fencing pattern ensures that flood water flows under the fence, minimising the likelihood that the fence will collect debris that had been washed down river when in flood. Up to three, 13ft 7 bar aluminium field gates will be included in the fence line to allow access if required. The fields are not currently grazed however in the event they are grazed in the future these access gates would allow periodic grazing at the right time of year.

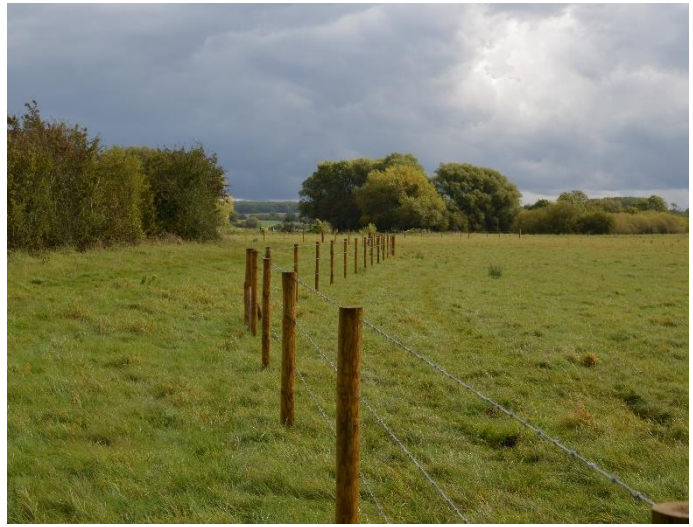
Figure 6 - New fence line at Nassington backchannel

With the new fence line creating much more space between the bank edge and the fence, the local angling club now have much better access to be able to fish on this section of the backchannel. Previously it had been tricky with the original fence line leaving very little room to fish, as well as not having access points on it.
