# Remove or modify structures to increase access for fish and eel

**Title:** Sharpsbridge Fish Passage Easement Project, Middle Ouse Restoration of Physical Habitats (MORPH)

**Technique:** Weir modification to rock ramp

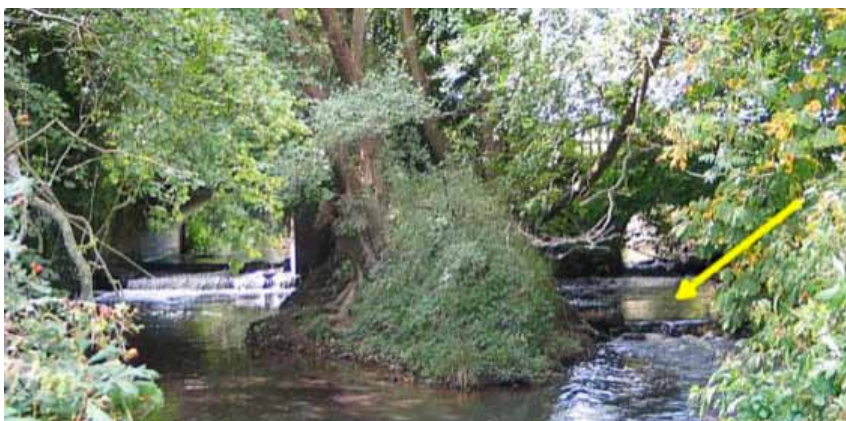
River prior to scheme. Yellow arrow indicates weir in the western channel.  
OART © copyright and database rights 2013

Sharpsbridge is a road bridge, with two culverts that carry flow under the road and an island in the channel downstream. The footings of the road bridge are formed of a solid concrete slab which acts as a weir, backing up flow. The height of the drop between the concrete slab and the water level was causing a barrier to fish passage. Previous work was undertaken to place rubble rock at the downstream extent of the concrete slab to enable fish migration; however, this began to function as an additional barrier. The aim of this project was to improve fish passage in one of the culverts, to allow free movement of fish upstream. In order to eliminate the barrier

to fish passage, the water levels in the downstream weir pool were raised by the addition of a rock ramp structure.

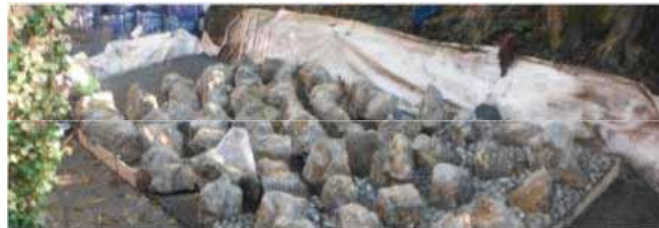
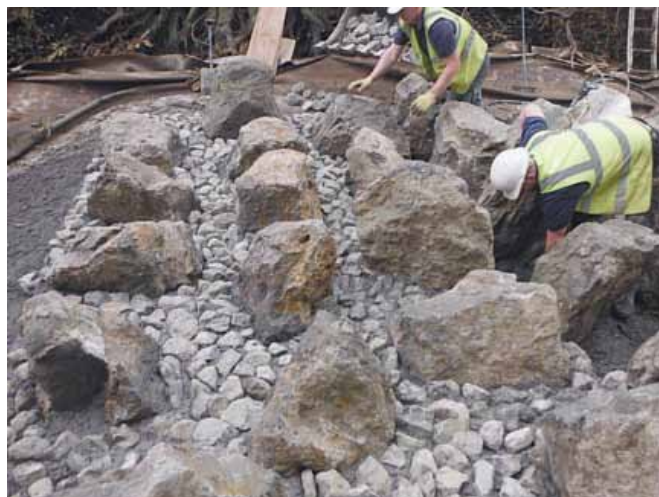
Rock ramp during construction

- The existing rubble rock weir was removed.
- A 4.5 m wide rock ramp was constructed in-situ, using granular fill and geotextile at the base, concrete at the upstream end, and rock armour forming the surface of the ramp.
- Kentish ragstone (a hard limestone) was used for the main perturbation boulders because of its durability.
- Rocks were positioned approximately equidistant, with increasing height of rocks upstream, to ensure a smooth gradient of flow over the former head drop.

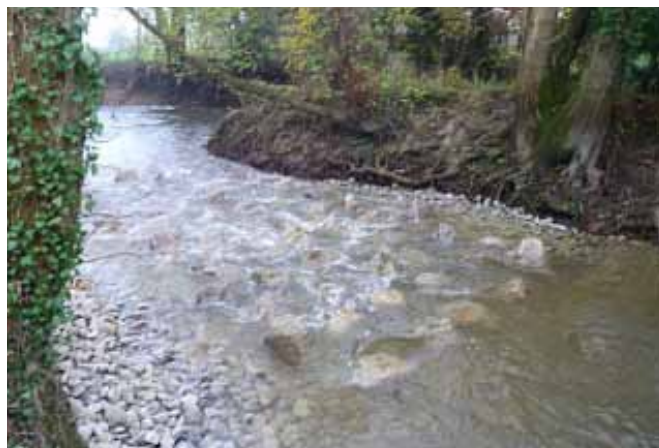
Rock ramp after completion of works

- During low flows, the flow velocities between the perturbation boulders and the water depth are expected to be good for fish migration. At high flows, the flow will be much slower flowing over the high-flow channel, and sufficiently deep to allow fish passage.
