**River Restoration Pilots**

**Cudworth Dyke: Baseline  
Geomorphological Assessment &  
Restoration Plan**

Job number 227042-30

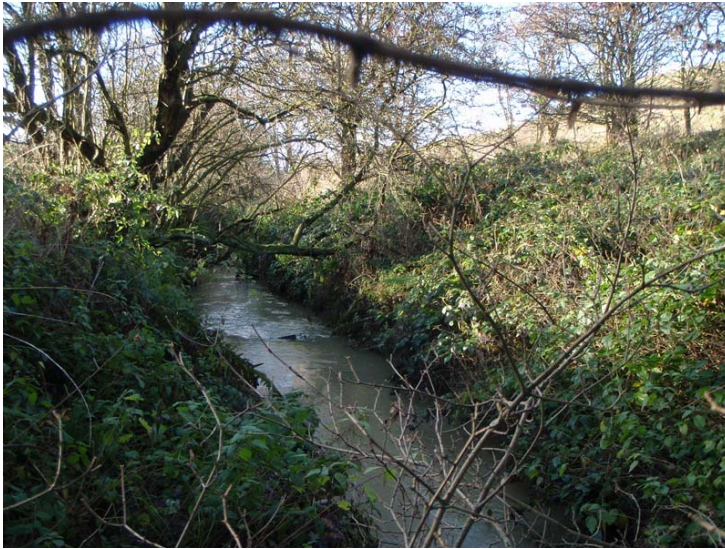
This reach extends from Sandy Bridge to Pools Ings. It shows more sinuosity than is apparent from the topographic maps and there are a large number of debris dams within it. It is however, overdeep and overwide, with a trapezoidal channel and lacks diversity in its morphology and habitat (Figure 4). Siltation is observed along most of the reach. Some key characteristics of this reach are:

- Dominated by runs with many small cascades at debris dams
- Localised fluvial bank erosion, with some evidence of incipient meandering (within confines of floodplain topography).
- Extensive silty deposits ranging from 0.25m to 1m of silt over a coarser substrate.
- Channel incision, with steep banks in places, undercutting and poor floodplain connectivity, especially in the upstream section of the reach
- Dense riparian vegetation upstream
- Lack of riparian vegetation downstream
- Obsolete weir and sediment mound
- Large woody debris (LWD) dams and urban rubbish dams (tires, bath tubs, etc.).

Figure 4 Example view of the river at Sandybridge Dyke

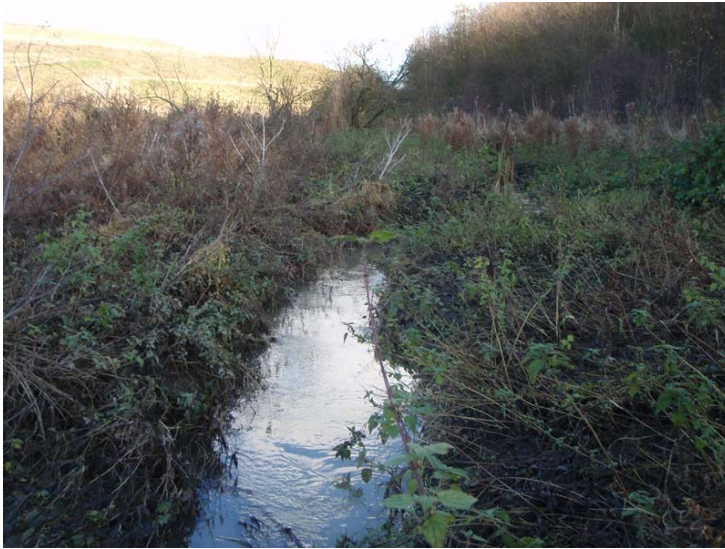
This reach runs along Pools Ings (Figure 5), and several small restrictive culverts can be found within it. Main general characteristics/issues:

- Dominated by runs affected by narrowing effect of marginal vegetation
- Coarse substrates overlain by silty deposits, increasing in thickness towards the downstream section of the reach.
- High connectivity with floodplain (evidence of regular out-of-bank events)
- Dense riparian and marginal vegetation
- Ponding behind restrictive culverts at crossings
- Narrower upstream and wider and deeper downstream

Figure 5 Example of the river at the Pools Dyke reach

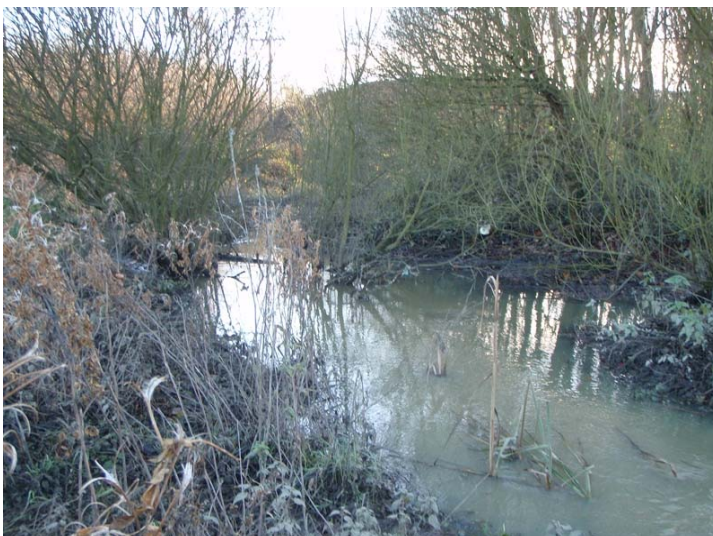
The most significant characteristic of this reach is its low gradient, which affects flow significantly, and is reflected by an increased level of siltation and in-channel vegetation (Figure 6). The main defining features are:

- Low gradient, flat floodplain
- Flows dominated by glides and ponded flow
- High amount of silty deposits within channel and along banks
- High connectivity with floodplain (evidence of regular out-of-bank events)
- Sinuous channel, overwide and overdeep
- Dense riparian, marginal and aquatic vegetation
- Inflow from canal overflow tributary and CSO

Figure 6 Example view of the river at the Pools Lane CSO reach

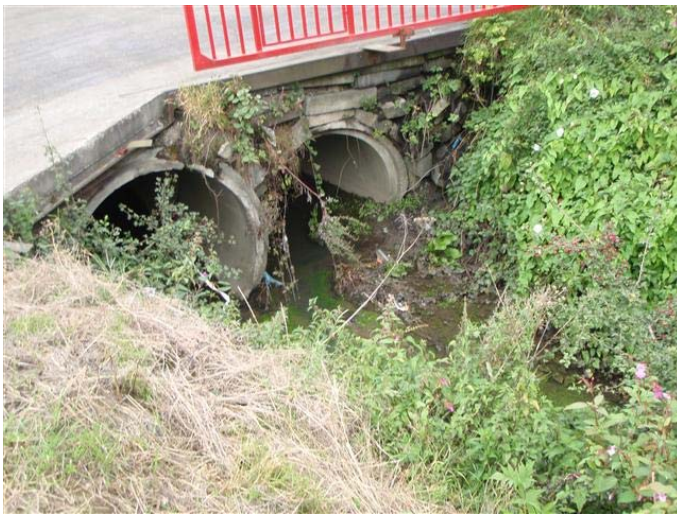
Most of the river is culverted within this reach, and consequently geomorphological characteristics could not be observed (Figure 7). The culvert runs underneath a scrapyards site with direct runoff into the waterbody and consequent water quality impacts. Key characteristics of this reach are:

- 20m long culvert under old railway embankment at upstream end of reach
- 200m twin concrete pipe culverts under scrapyards
- Where visible, channel narrower, channelised/confined
- Where visible, fast flowing runs with coarse substrates
- Urban rubbish and direct surface runoff from scrapyards and roads

Figure 7 Example view of the river at the Boulder Bridge reach

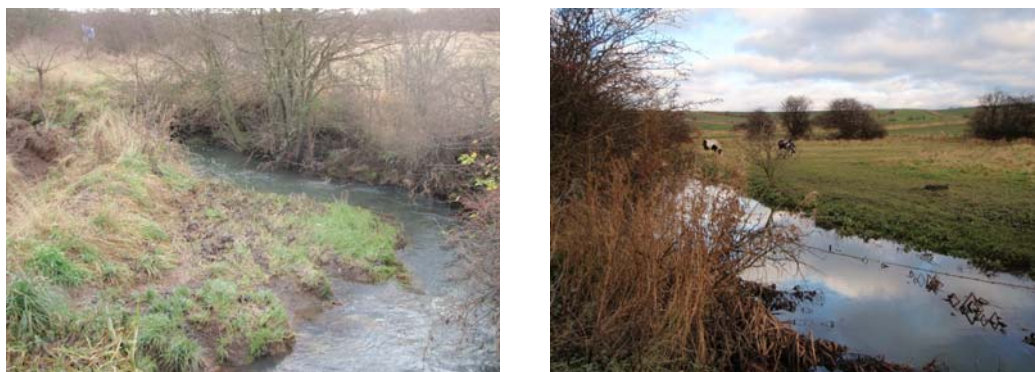
This reach shows a significant change from Carlton Marsh (Figure 9), with increased flow diversity and going from a dense riparian vegetation cover to a lack of a riparian buffer. The following are the main defining characteristics:

- Dominated by runs but shows more flow diversity than reaches upstream
- Less silt deposits along bed (fine and coarse sediments visible)
- Localised overdeepening and overwidening
- Lack of riparian vegetation downstream
- Sediment delivery along left bank due to surface runoff from fields and poaching by horses
- Good connectivity with floodplain in lower half, with existing floodplain wetland features

Figure 9 Views of the river at the reach downstream of Carlton Marsh
