**Arborfield nature like weir bypass channel - October 2012 photo update**

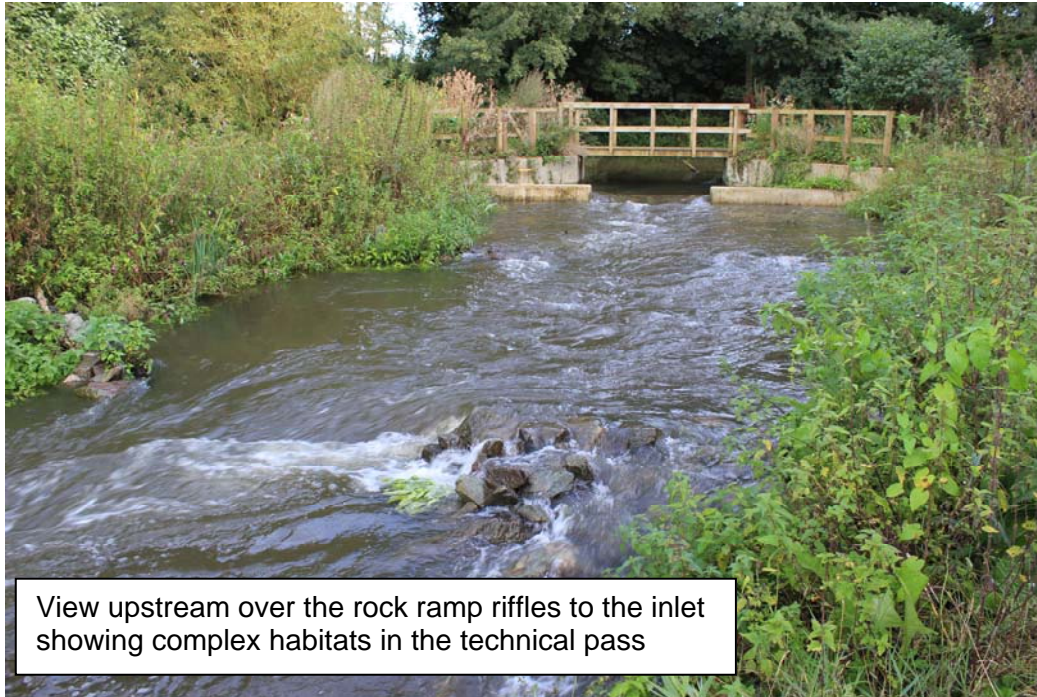
View upstream over the rock ramp riffles to the inlet showing complex habitats in the technical pass

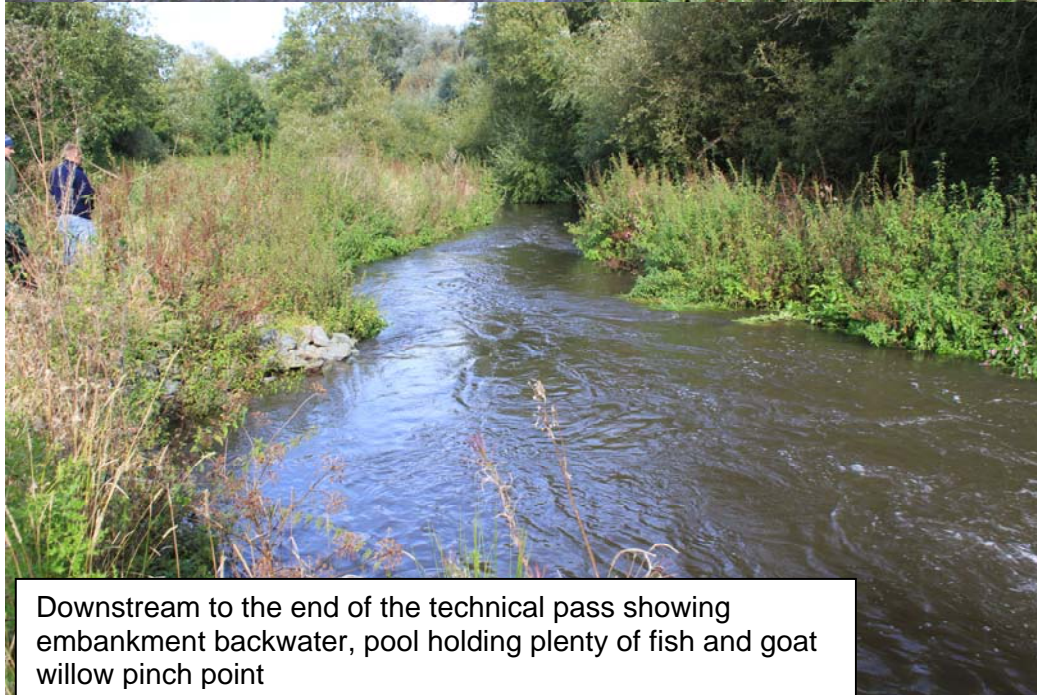
Downstream to the end of the technical pass showing embankment backwater, pool holding plenty of fish and goat willow pinch point

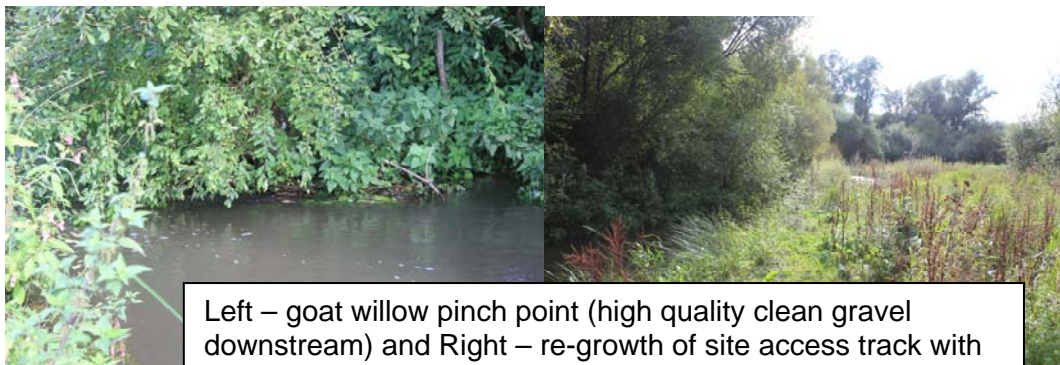
Left – goat willow pinch point (high quality clean gravel downstream) and Right – re-growth of site access track with reeds and rushes

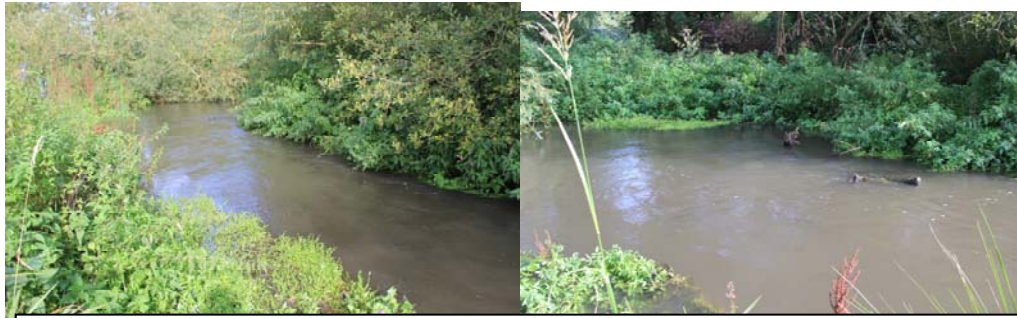
Left – natural bypass to fallen willow where the largest fish (chub 30cm) were caught during October fish survey, Right – variation in channel width and woody debris offers good holding habitat for a variety of fish

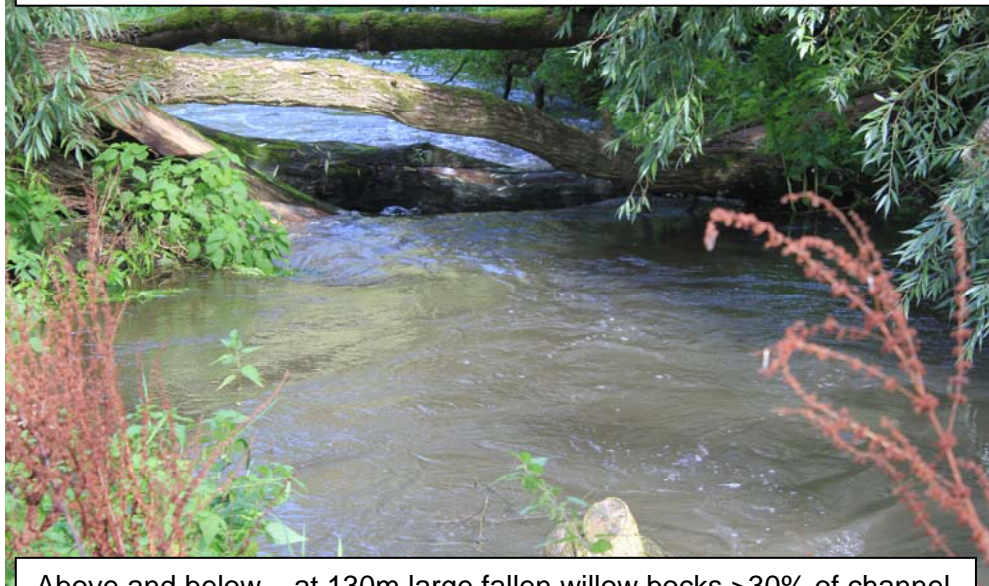
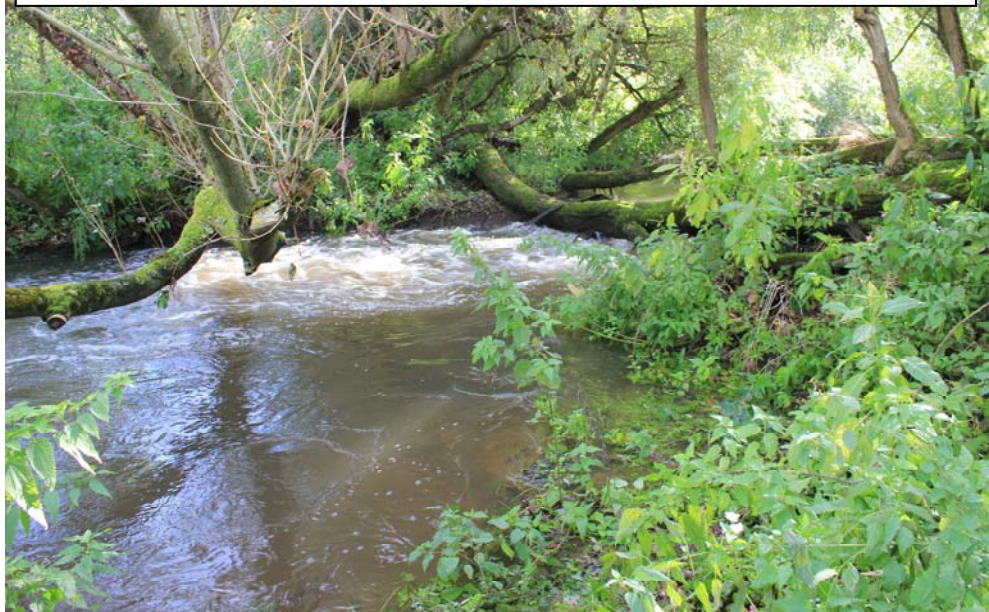
Above and below – at 130m large fallen willow bocks >30% of channel elevating upstream water levels to benefit the wet woodland (see photo at end). High quality clean gravels on tail of pool downstream

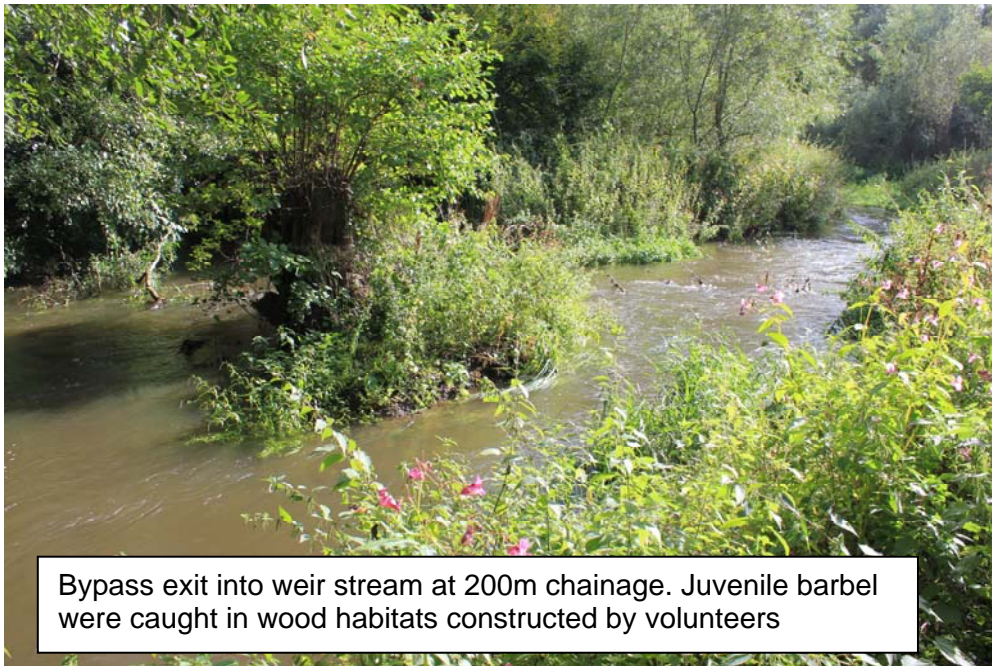
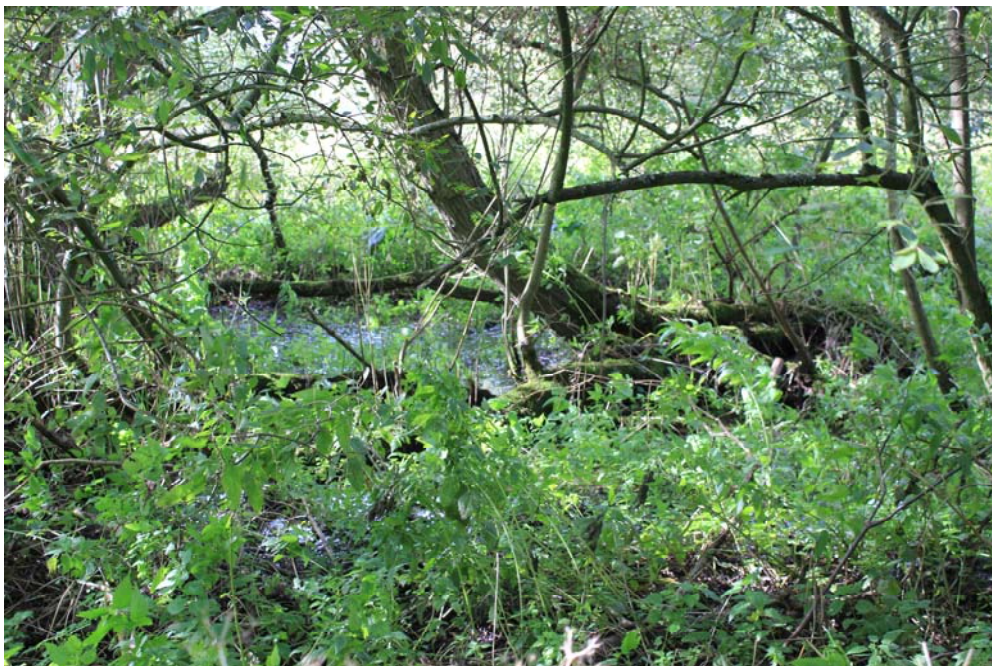
Wet woodland – one of our targets was to improve the quality of wet habitats. Feeds constructed discharge water into standing areas (right) and habitat features in the bypass ensures water connectivity with the wet woodland
