Long Preston Restoration Summary

Final Report

October 2011

Environment Agency

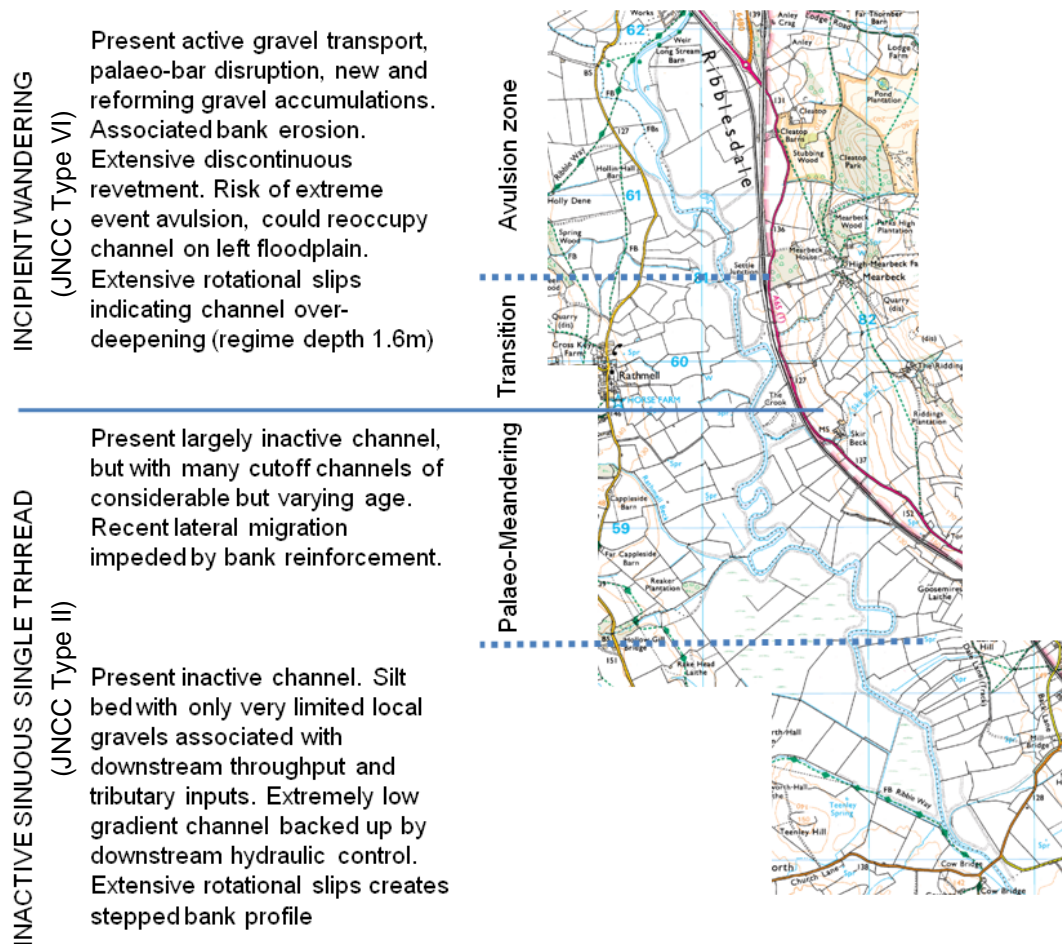
Figure 1-1: Summary character of the River Ribble through Long Preston Deeps highlighting major alterations to the natural river and floodplain dynamics.

Both river characters presently exhibit modified morphology and ecology due to past and present engineering and management activities (see Figure 1-1). The wandering channel is exhibiting heightened bank erosion, as you would expect. The floodplain is currently almost completely disconnected from the river due to the physical processes operating within the channel which are as a result of the past management measures, leading to significantly reduced levels of floodplain inundation (i.e. online flood banks).

The primary causes behind the unnatural watercourse and floodplain at the site include:

Grossly altered flooding regime

Extensive flood banks confine all but the more extreme flows to the main channel and immediate overbank area. This is affecting both in-channel and floodplain morphology and ecology. Elevated in-channel flood flows frequently create energetic conditions sufficient to mobilise gravels and prevent vegetative stabilisation which is important for fisheries as stable gravels provide better spawning habitat.

In many places the protection has failed to prevent rotational slips along the banks with the revetment moving into the river as part of the slipped mass.

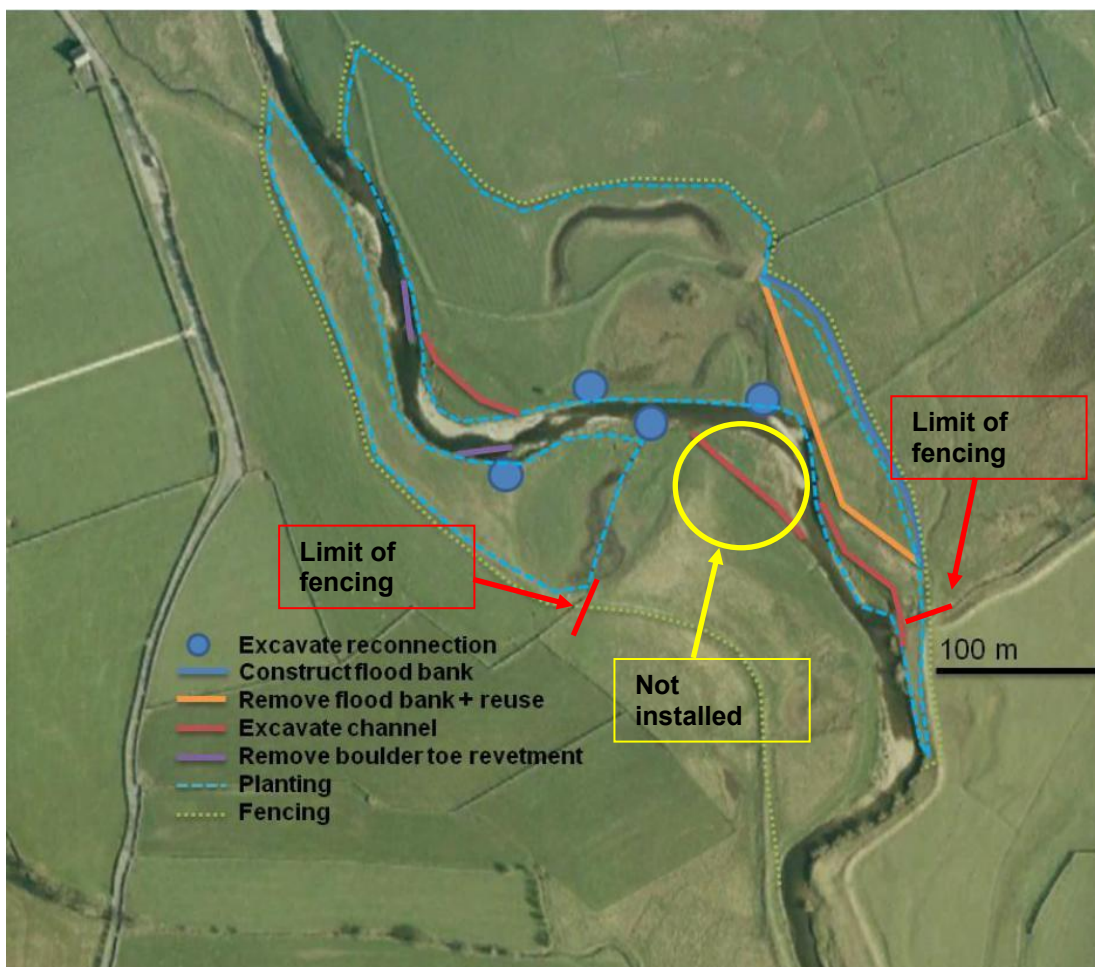
Figure 2-1: Original restoration plan

The original restoration plan devised for the Long Preston Deeps has changed following consultation with landowners. Figure 2-1 below shows the original plans for this phase of the restoration works and further plans are provided as Appendix A.

The significant change from this plan is that the right bank chute channel could not be excavated as landowner consent was not given. The fencing on the right bank does not stretch as far as shown above, it is now stopped at the edge of the marked planting section. Similarly over the left bank, the fencing stops at the end of the downstream chute channel.

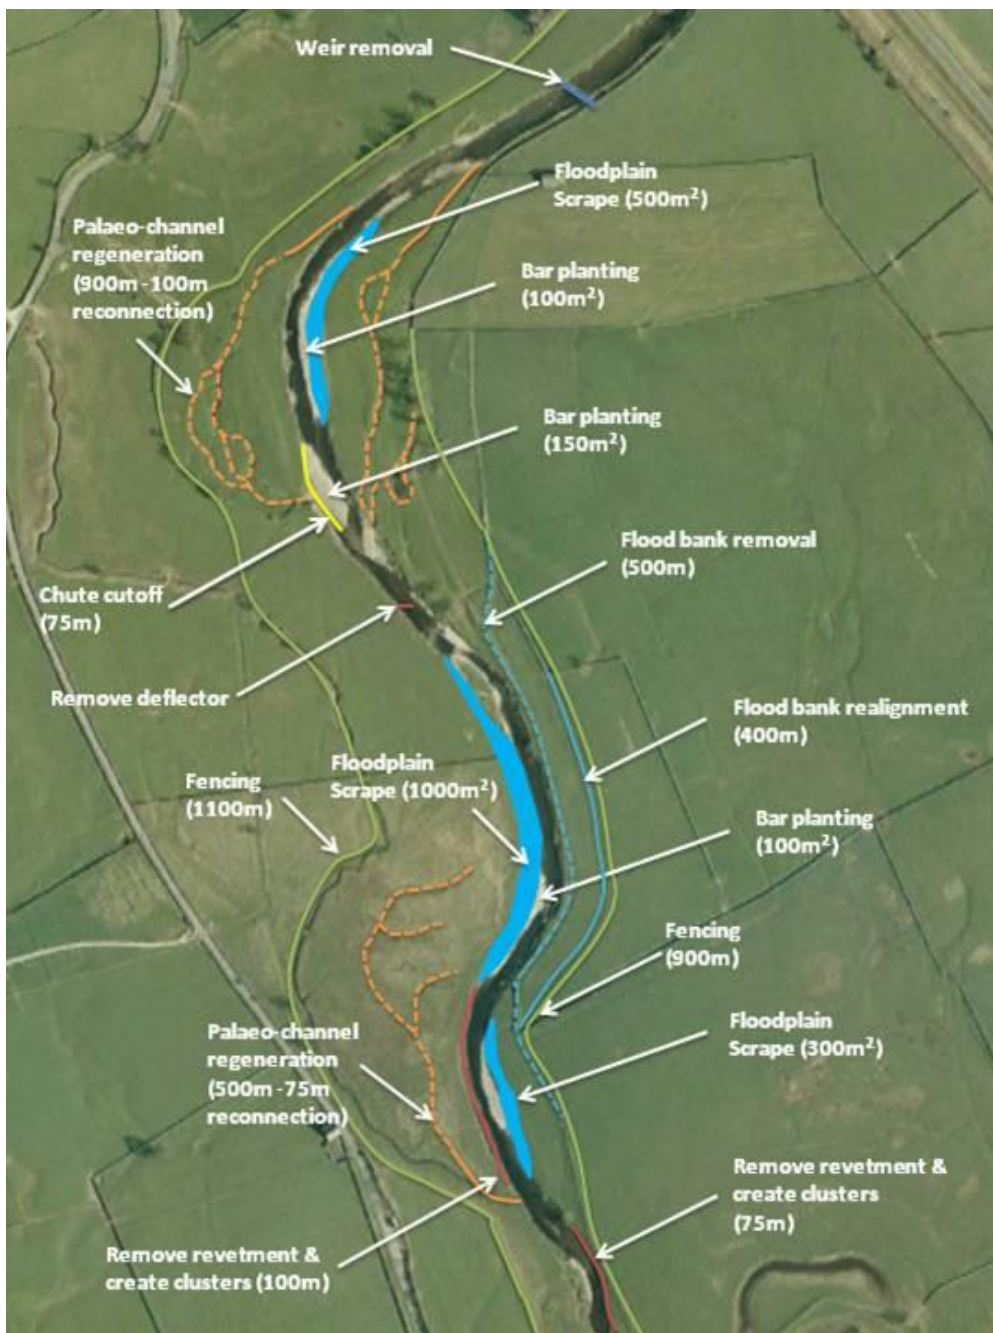
Figure 3-1: Proposed upstream restoration works

The outline restoration works for the reach upstream of the completed restoration section are shown above in Figure 3-1. The perceived benefits are:

- Weir removal at Long Stream Barn (downstream of Settle Railway Bridge) - complete removal will increase the gradient locally encouraging riffle development, partial removal would lead to flow concentration and the development of a deeper channel comprised of coarser winnowed material and sediment deposition and bar formation in lower energy areas. The potential for lateral erosion would be enhanced locally creating steep river cliffs. This may also lead to the re-exposure of old masonry protection and threaten a dry stone wall running along the left bank of the channel.

- Floodplain scrapes - the degradation of the channel bed of the Ribble over time has significantly divorced the channel from the floodplain in several locations. There is little scope for creating chute channel in the scrape areas due to the significant depth of the floodplain in these locations. Therefore, to restore some connectivity between the channel and floodplain in these areas, it is proposed to scrape some floodplain material to create a secondary lower level floodplain.

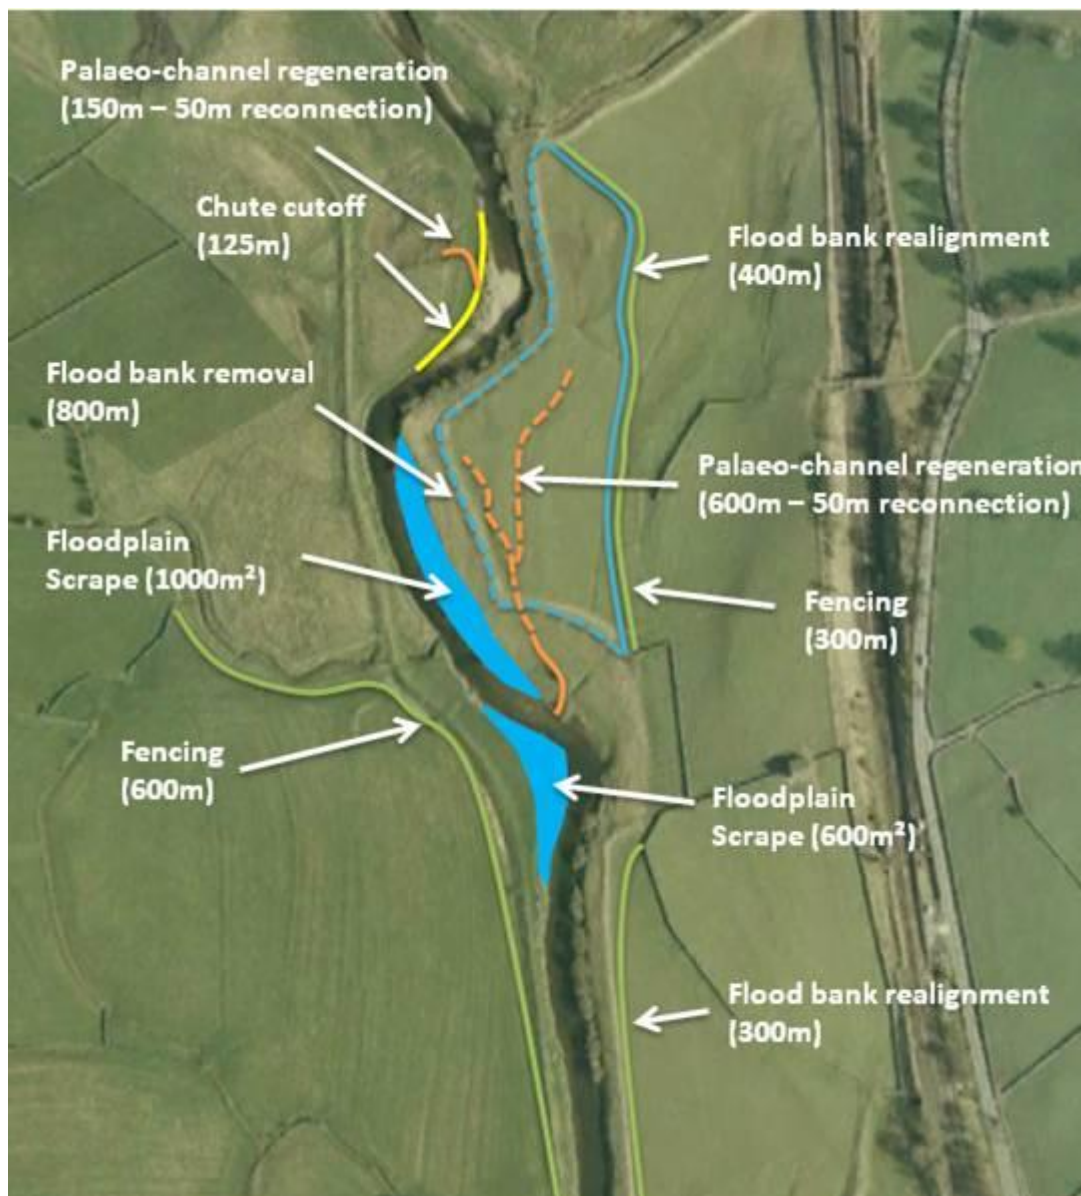
Figure 3-5: Proposed downstream restoration works

The outline restoration works for the reach downstream of the completed restoration section are shown above in Figure 3-5. Whilst not as extensive as the potential in the upstream reach, there is considerable scope for restoration in this downstream section. The perceived benefits are very similar to those discussed above for the upstream reach (section 3.2) as the proposed works are of a similar nature.
