RIVER IRWELL

North Manchester Restoration Project

Restoration and Enhancement

November 2009

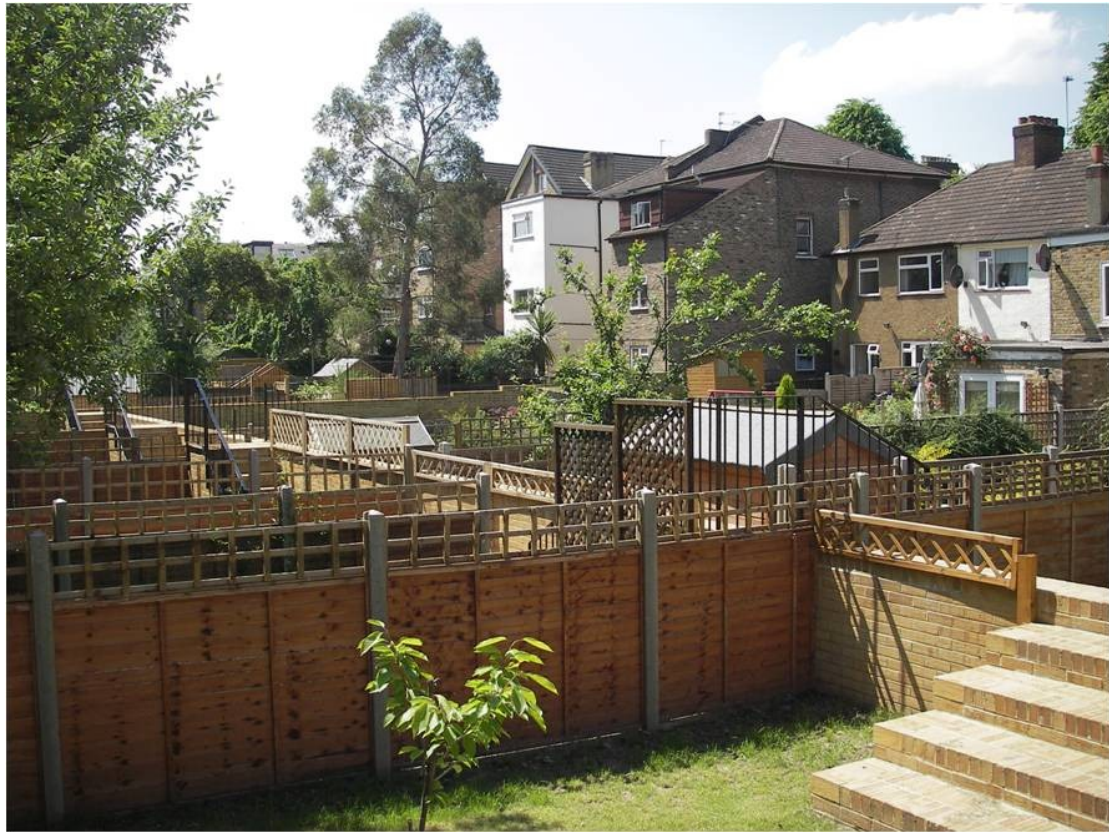
Figure 2: Flood defence wall set back and incorporated into gardens. River Quaggy, Lewisham.

Currently, much of this section is also walled. Whilst it is recognised that there is a need to stabilise the bank where it is close to properties, floodwalls, where deemed necessary, could be set back to provide more space for natural river forms and processes to occur along this section. If the weirs in this section were removed in conjunction with work completed downstream at Strongstry, this could provide beneficial opportunities to the whole reach in terms of sediment continuity and management and habitat improvements. Any changes could, in this way, be designed within the context of flood alleviation concerns. It would be worth reviewing the River Caldew project in Carlisle (<http://www.environment-agency.gov.uk/research/planning/109005.aspx>), where this approach has been adopted. New flood walls have been designed to integrate with footpaths, and old bank protection walls have been left in situ but it is recognised that these will degrade over time and give the watercourse and riparian zone space to recover. Even where space is extremely limited, there may be opportunities to design habitat features into walls, and where gardens abut the river, they can be landscaped to incorporate flood defences. A good example of this has been achieved in London, in Lewisham, on the river Quaggy (see Figures 1 and 2). An alternative approach would be to consider using more bio-engineering approaches, as have been completed on the River Skerne, Darlington. Here, and on the River Brent in London (Figure 3), crushed concrete, interspersed with willow poles and tied into the bank, has achieved bank stability and a more natural riparian edge. To develop such an option would require the regrading of the banks, a 'harder' stone bolder toe revetment (but well hidden below the waterline) and a commitment to some future management to cut back the vegetation every few years to ensure structural integrity of the bank protection.

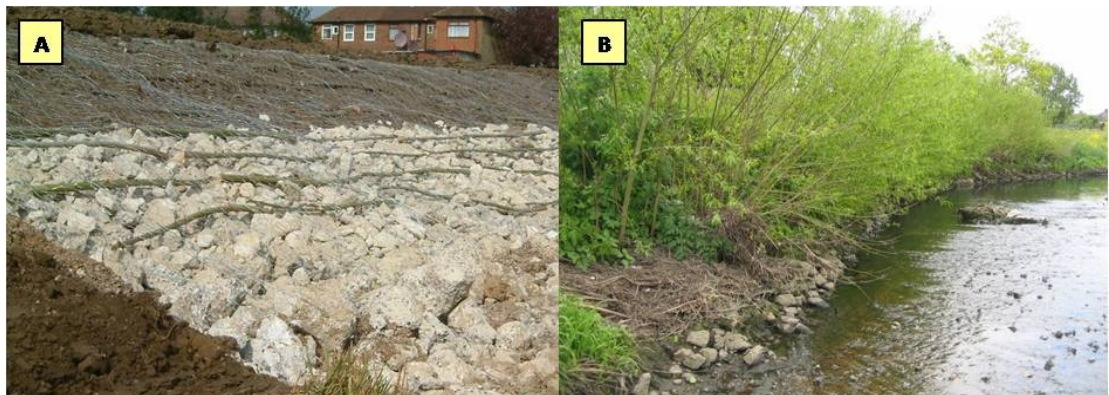
Figure 3: Crushed concrete and willow pole revetment A: as installed, in 2003; and B: with vegetation establishing, in 2005. River Brent, Willesden.

side bar features have formed, indicating that this section is over-wide for most flow conditions. Laying back the bank and, if necessary, stabilising with some geotextile-type techniques as discussed in section 2.2 (Figure 3) could significantly improve this short section if the opportunity arose, or when this asset requires replacement. The river is culverted for approximately 80 m underneath the industrial estate at Mill Road, but as can be seen from Photo 11, the industrial site is located on top of the culvert, therefore its removal would currently be impractical and would necessitate a change in land usage to allow for improvements along this section of the river.

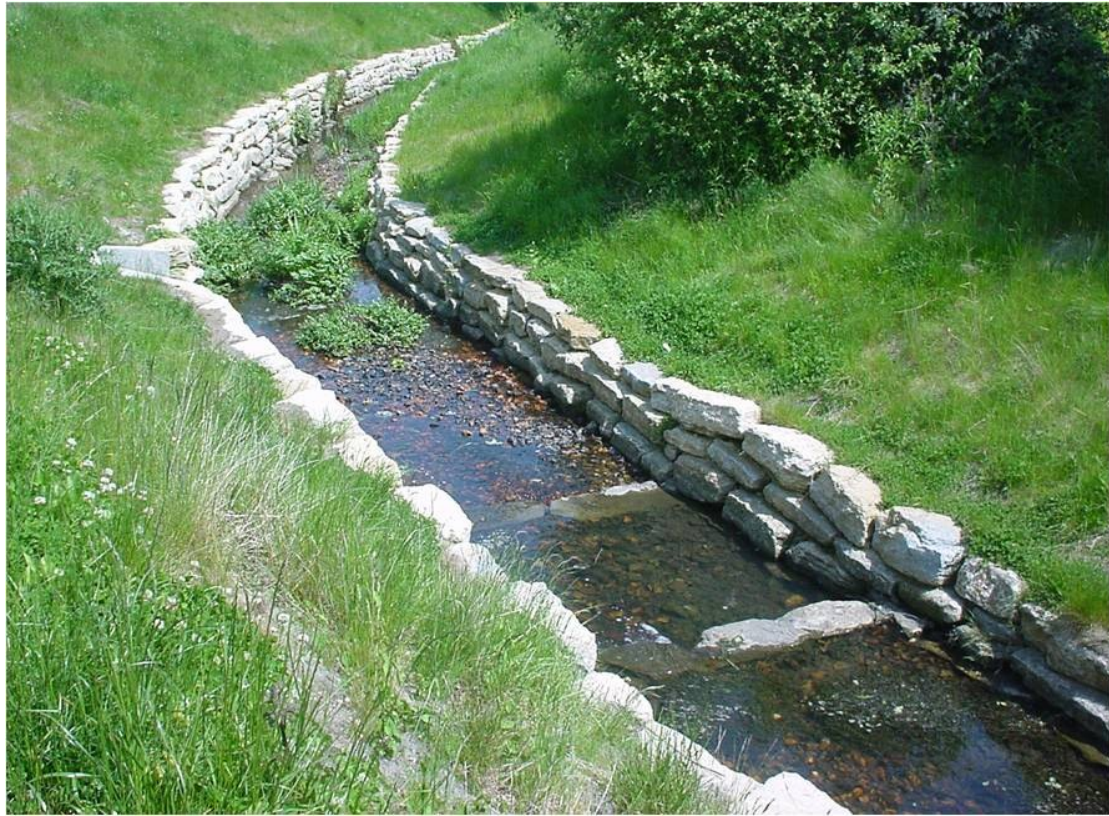
Figure 5: Small 'check weirs' on Tilmore Brook, Petersfield. Note the gravel being held behind the structures.

There are various projects of a similar type that have been completed, or are in the process of being designed in the UK. At Tilmore Brook (Petersfield, Hampshire), small check weirs were introduced to prevent head cutting, with new walls installed to replace sheet piling, using natural stone with crevices to allow the growth of vegetation. These walls were also slightly stepped back. Over time this section has begun to naturalise with vegetation and gravels (see Figure 5). Similarly, on Tanners Brook (Newport, Isle of Wight) a small project is being designed where a concrete bed is to be removed without impeding the structural integrity of the bank walls. This project is being led by the FRB team at the Hampshire office, Colden Common. Other initiatives have also been completed such as that on the Inchewan Burn, at Birnam in Scotland. Here, a gravel and cobble bed was designed-in where previously a Reno (gabion) mattress bed-lining structure existed to prevent down-cutting. The result was more of a pool-and-cascade section which looks more natural than hard-engineered weirs (Figure 6). The objectives of this work were to restore free passage for fish; to allow natural sediment transport; and to mimic a natural section of the burn with regard to landscape and aesthetic benefits.

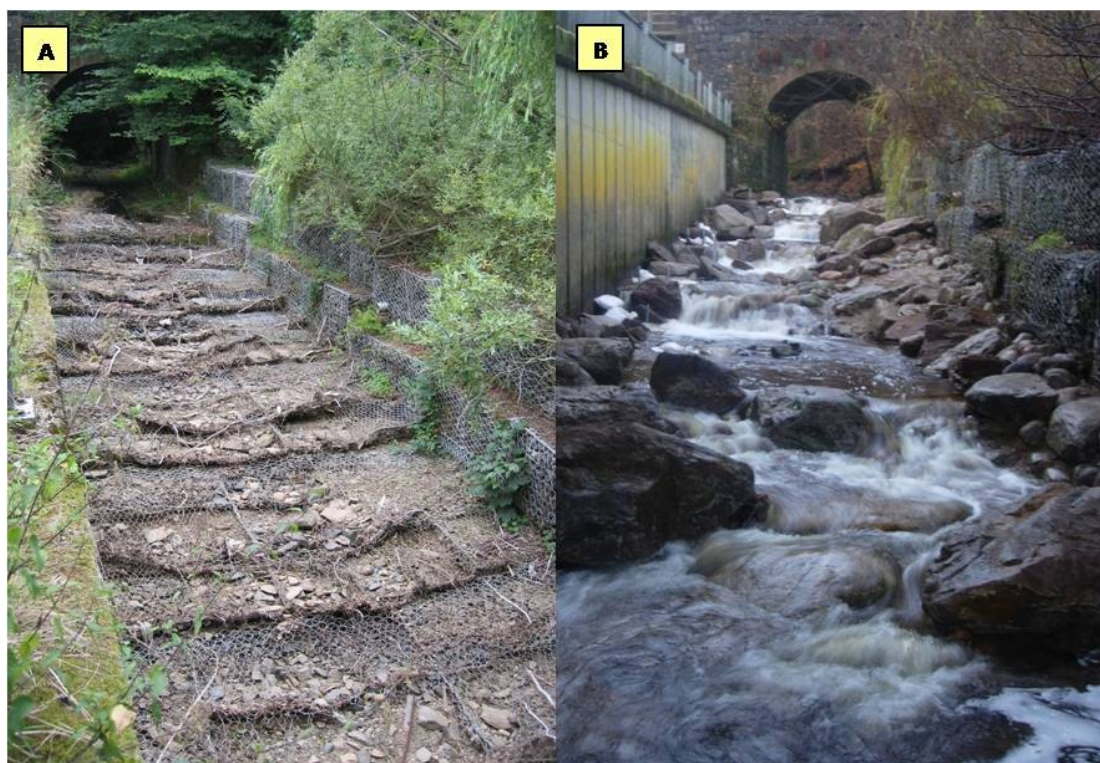
Figure 6: Replacement of gabion mattress with cobble pool-and-cascade, Inchewan Burn, Birnham. A: Before. B: After.

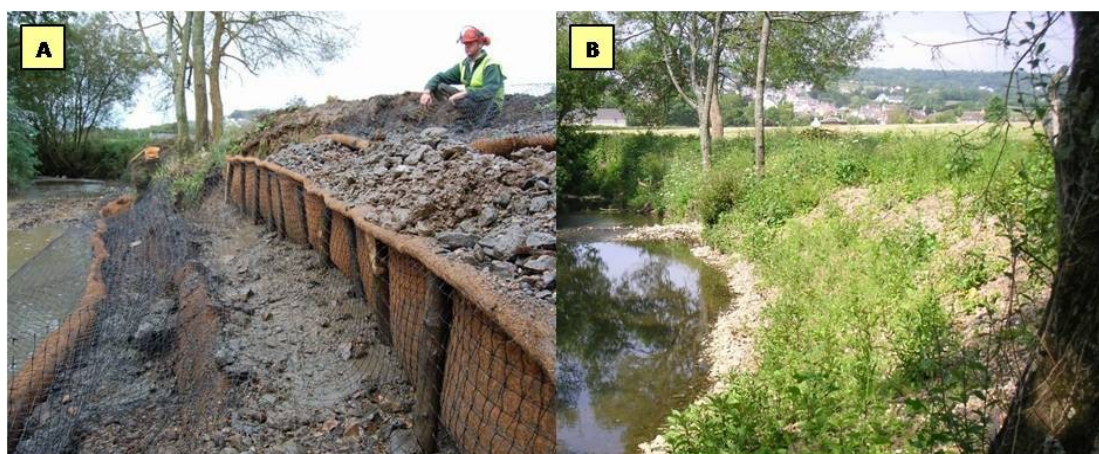
Figure 8: Back-filled coir net terrace revetment, River Char, Charmouth. A: As built, in 2005. B: With vegetation establishing, 2006.

Further downstream of this there is a length of gabion walling supporting the bank (Photos 66 and 67), which is marked as a natural channel section on the NFCDD database. This is rusting and in poor condition and is likely to collapse in the near future. It might be worth considering its removal and, if necessary, replacement with a semi-natural bioengineering option. Laying back the bank and installing low lying wooden 'walls', back-filled with soil and geotextile liner maybe one option. If with the design is to include local native bankside trees, these should quickly take hold and form a natural stable bank. Such a project has been completed on the River Char at Charmouth, close to a sewage treatment works (see Figure 8). Some future maintenance may be necessary (e.g. coppicing on occasions) to maintain structural integrity, but this should be low-key and low cost. It is assumed that bank stability is necessary at this location since extensive erosion may impact on the feeder channel to reservoirs downstream.

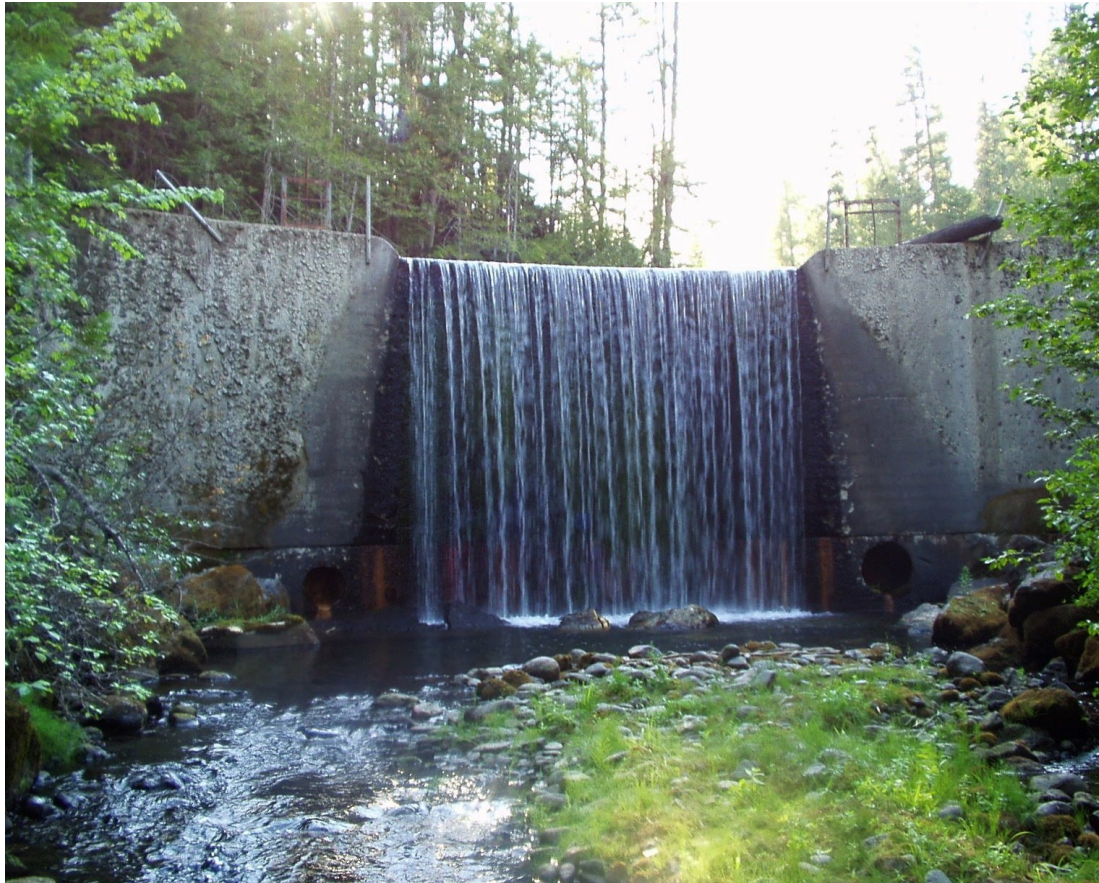
Figure 10: 6m dam in place, before works

Removal of a large (6m high) dam on Cedar Creek, in Washington State. The project involved extensive dewatering (bypassing the dam and its backwater), removal of over 15 000 m³ of sediment, and bank protection to prevent excessive erosion as the new channel adjusted, upstream. See captions for further details. All photos courtesy of Bill Norris, Inter-Fluve Inc.

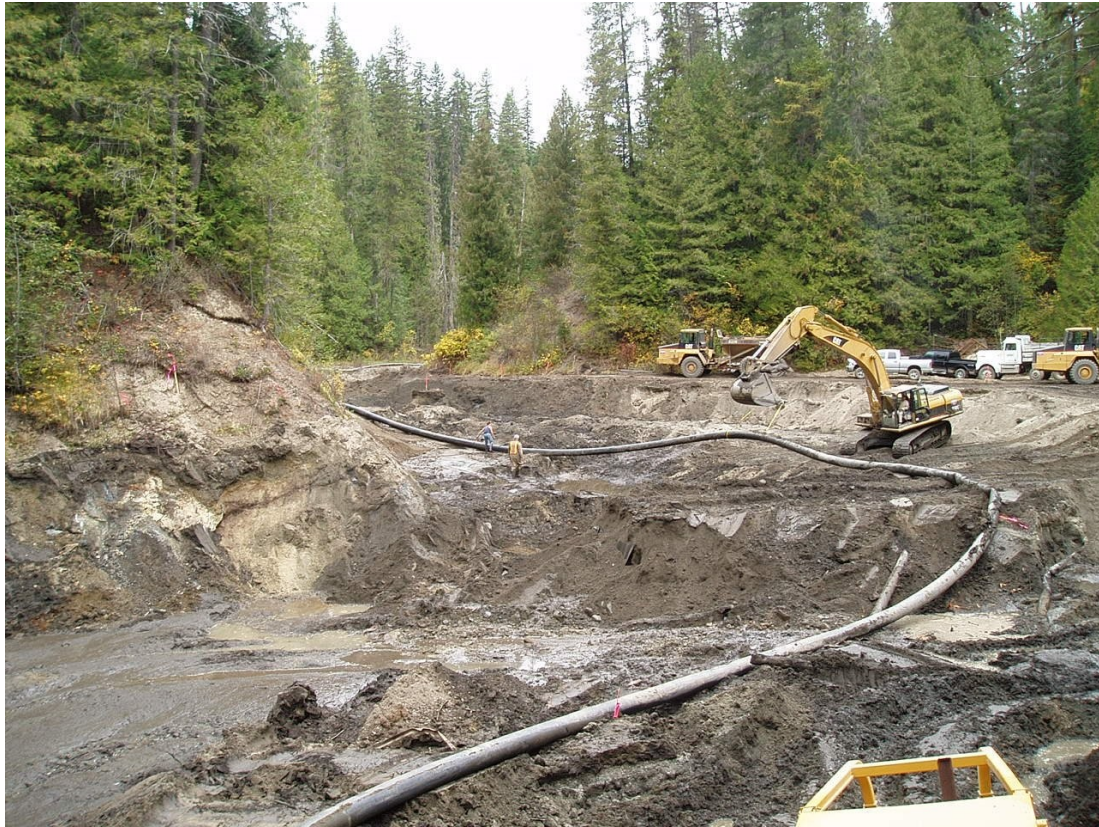
Figure 11: Sediment removal operation, with diversion pump line visible

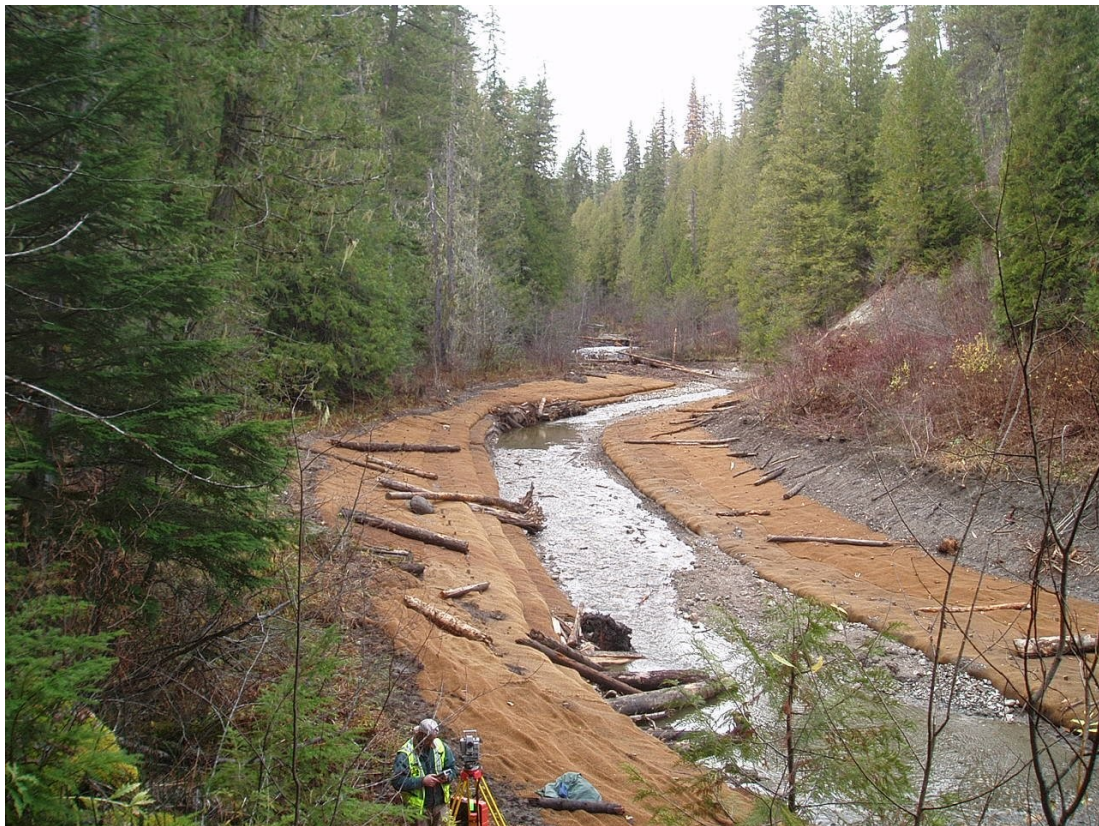
Figure 12: Coir matting bank protection (later planted out with native species), with coarse woody debris added to dissipate energy and increase flow diversity

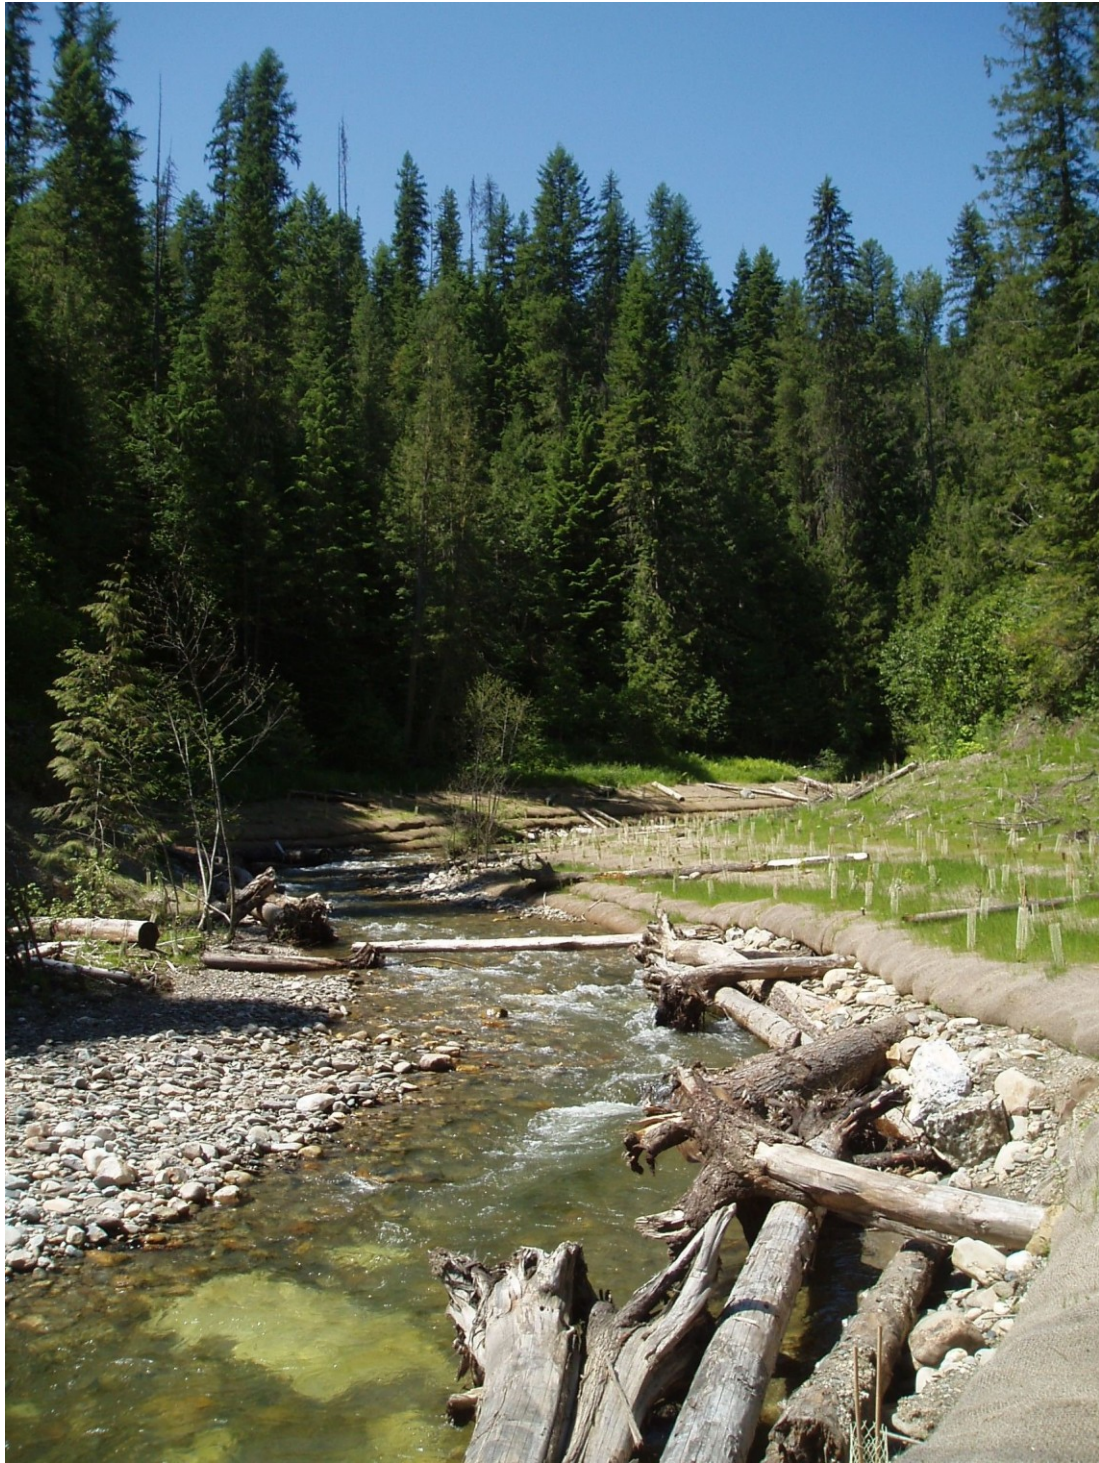
Figure 13: Cedar Creek starting to naturalize after first winter. High flows have redistributed bed material and woody debris
